# **WITKOFF GROUP**

**33 MAIDEN LANE  
MANHATTAN, N.Y. 10038**

Re: 33 Maiden Lane  
Ambient Project # 211520

Re: 33 Maiden Lane  
Condition Assessment

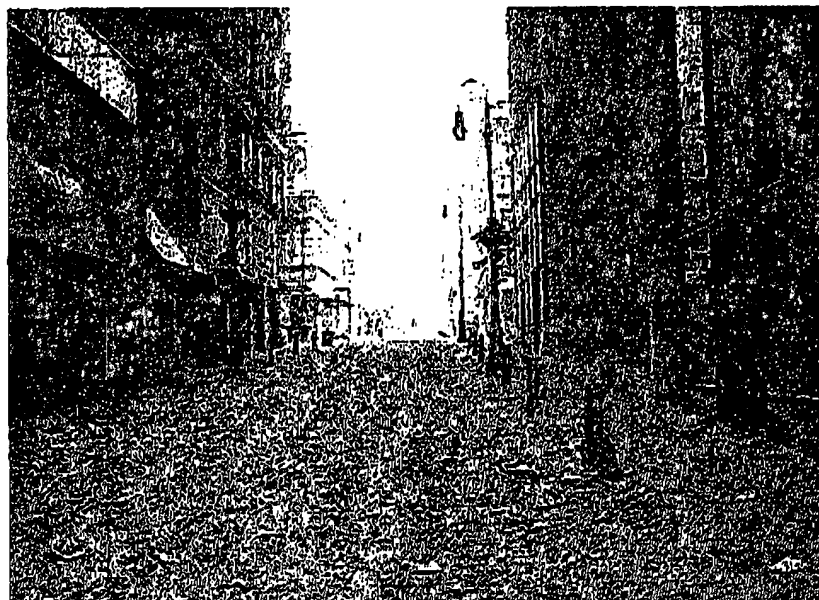
Image14.jpg

Sept 12, 2001  
NASSAU ST.

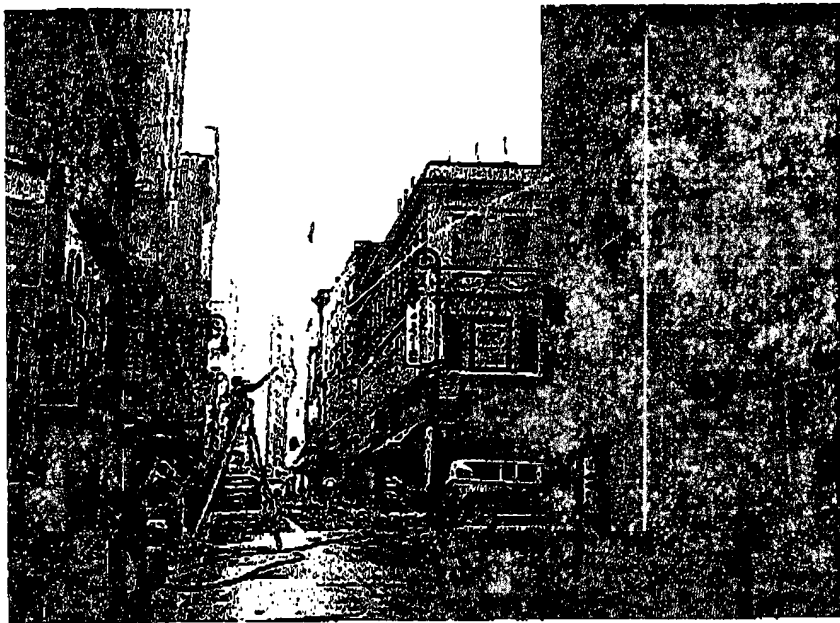
Image40.jpg

Sept 16, 2001  
NASSAU ST.
