# **ASBESTOS CONTROL PROGRAM EMERGENCY RESPONSE DIAGRAM**

NAME Carl Lutchmeyer BADGE # A058 DATE 2/23/02  
 LOCATION 125 Cedar St

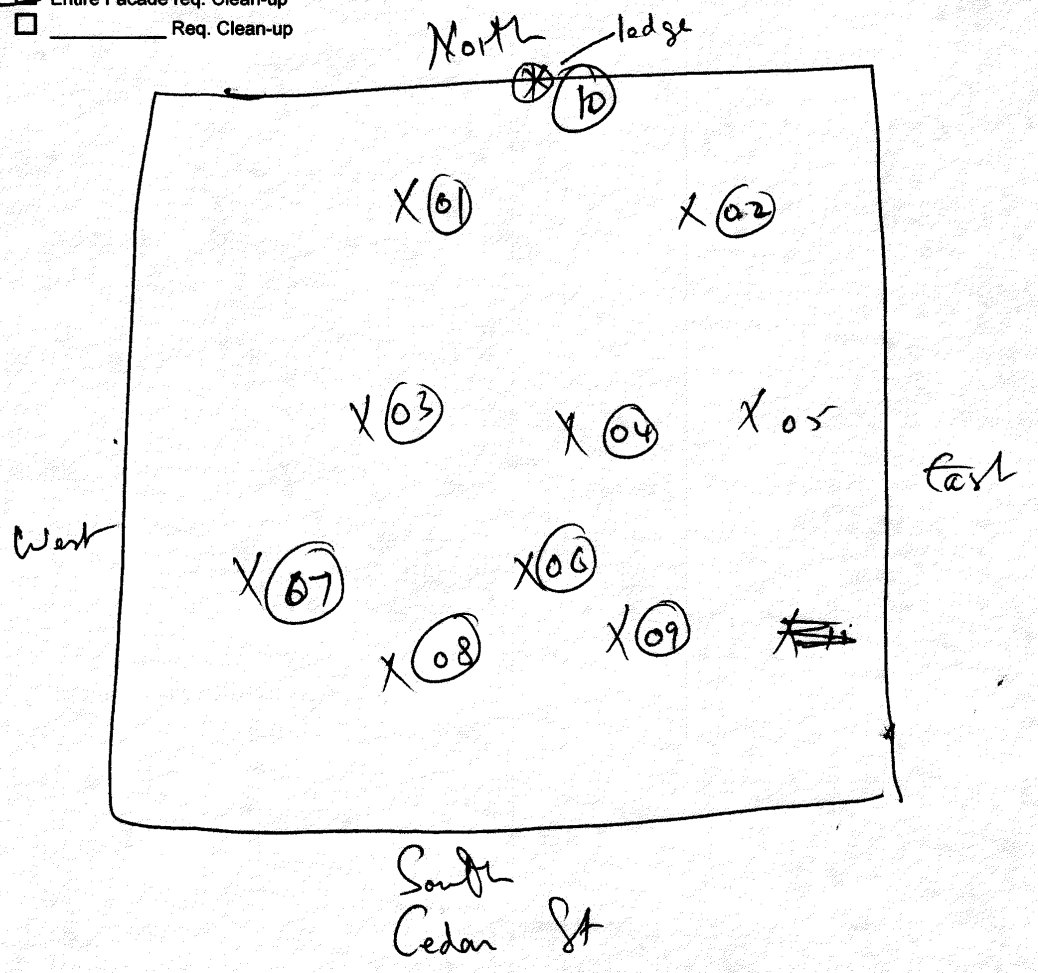
- ROOF**
- ☐ No Visible Debris
  - ☒ Entire Roof Covered with Debris
  - ☐ Partial Roof Covered
    - ☐ Local/Isolated Areas
    - ☐ Gutters
    - ☐ 25% of the roof
    - ☐ 50% of the roof
    - ☐ 75% of the roof
- FACADE**
- ☐ Clean
  - ☒ Entire Facade req. Clean-up
  - ☐ \_\_\_\_\_ Req. Clean-up
