**BUREAU OF ENVIRONMENTAL PROTECTION  
ASBESTOS AND LEAD CONTROL PROGRAM  
59-17 JUNCTION BOULEVARD  
CORONA, NY 11368**

**BULK  
ANALYSIS CHAIN OF CUSTODY**

Premise: 102 NORTH END AVE

# **ASBESTOS CONTROL PROGRAM EMERGENCY RESPONSE D I A G R A M**

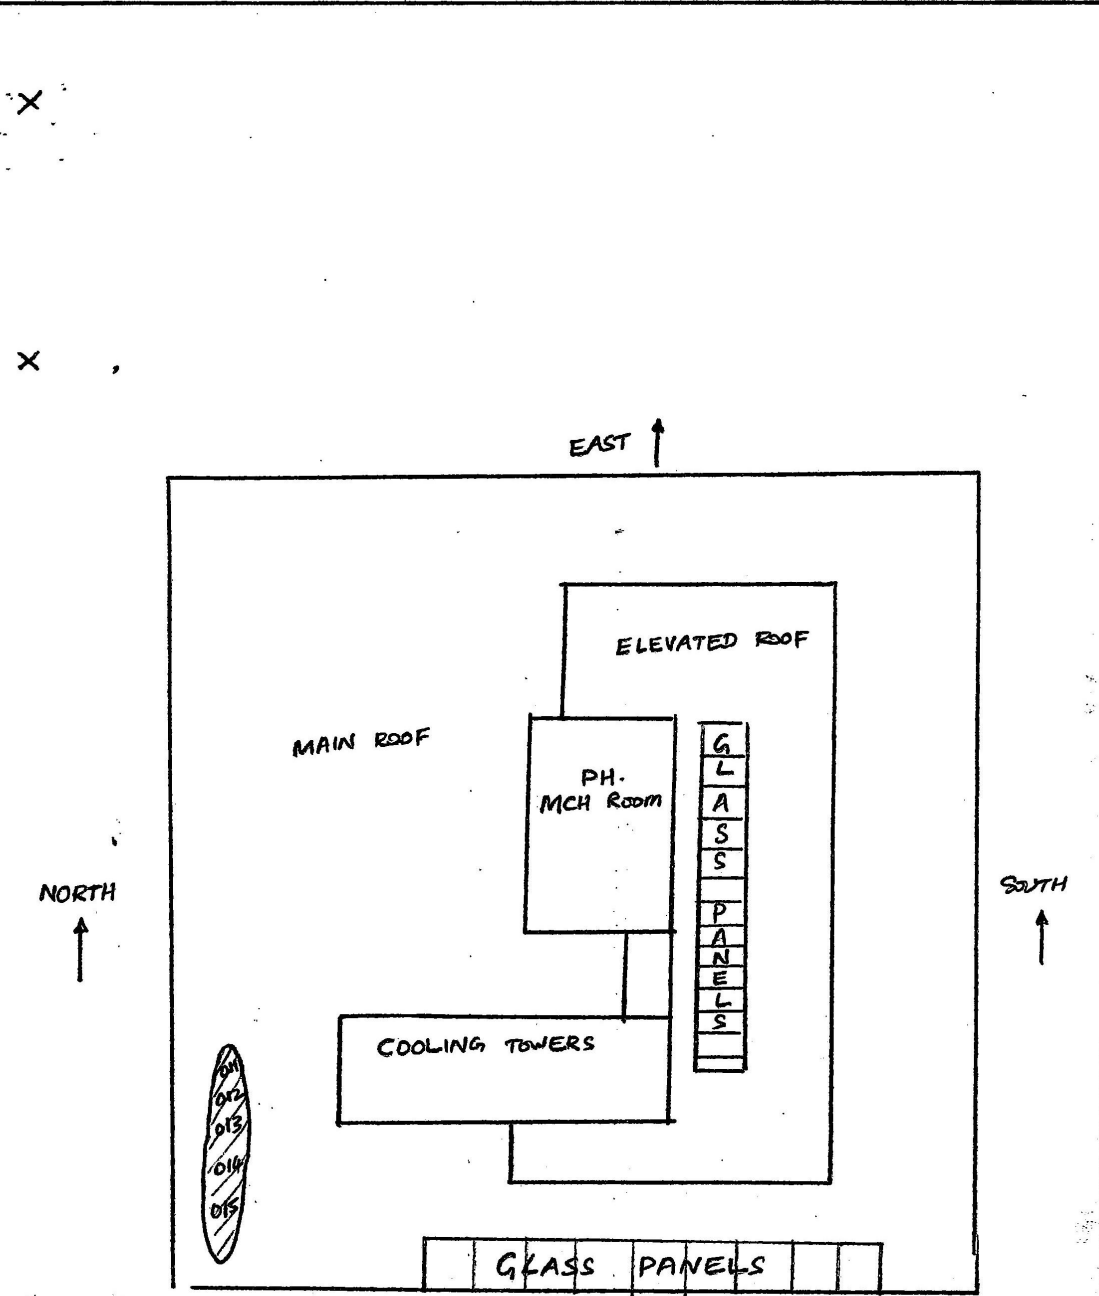
① SAMPLE LOCATIONS.

1. Roof was made of rubber
2. The glass panels contained very fine layer of dust
3. The roof was completely cleaned as per Engineers.
4. The Embassy suites was completely cleaned.
5. The restaurants (Rear side (East)) were not cleaned & mild dust observed on facade ledges.

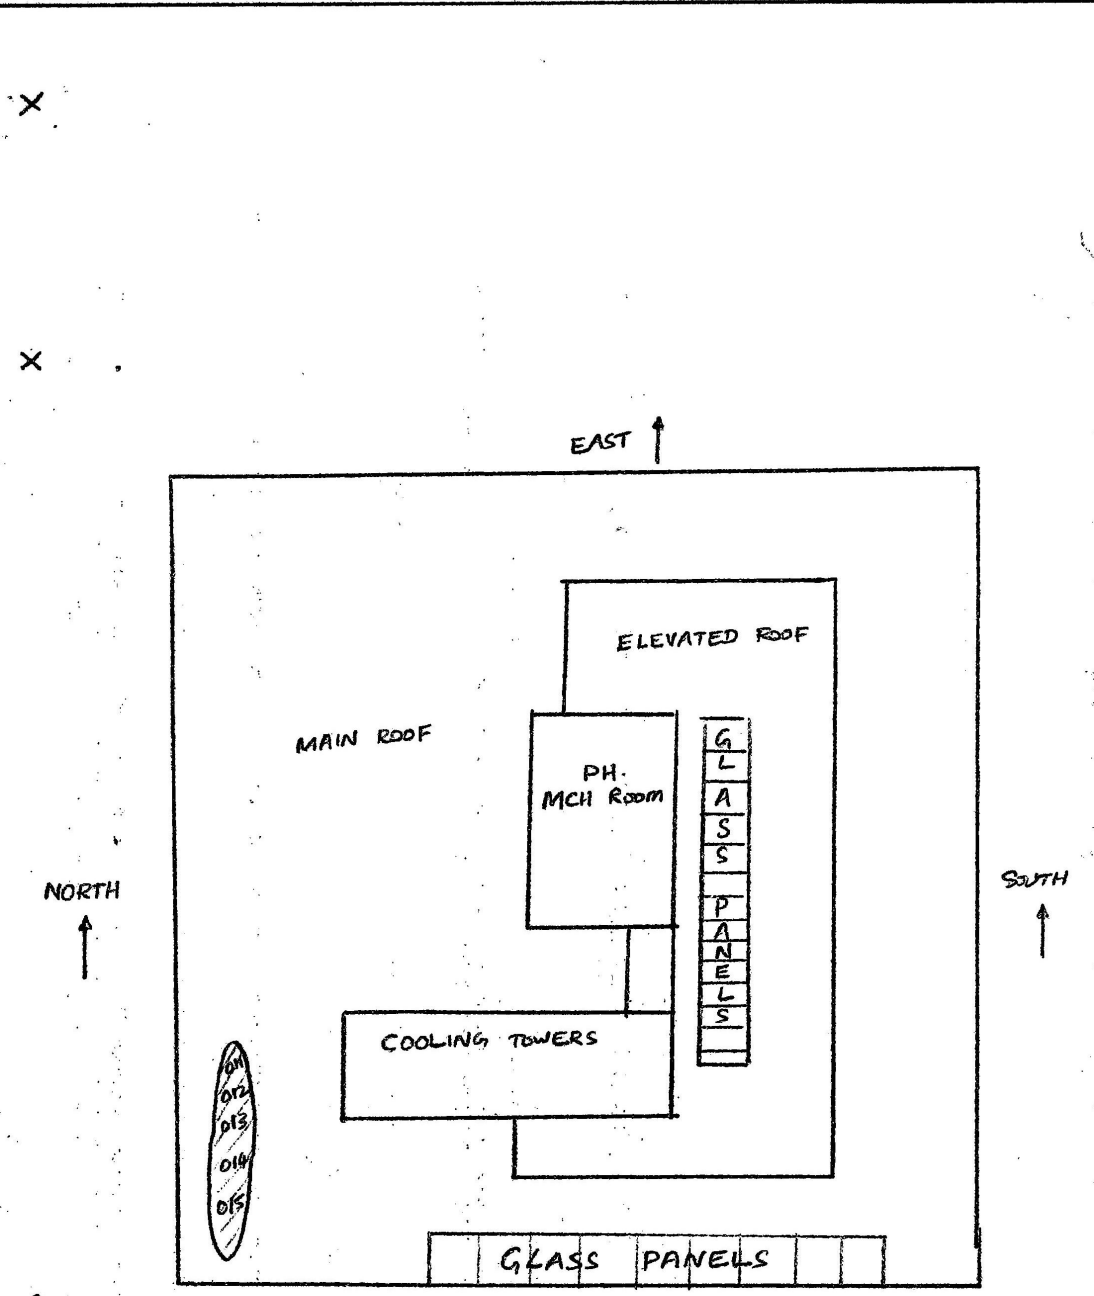
① SAMPLE LOCATIONS.

1. Roof was made of rubber
2. The glass panels contained very fine layer of dust
3. The roof was completely cleaned as per Engineers.
4. The Embassy suites was completely cleaned.
5. The restaurants (Rear side (East)) were not cleaned & mild dust observed on facade ledges.
