**BUREAU OF ENVIRONMENTAL PROTECTION  
ASBESTOS AND LEAD CONTROL PROGRAM  
59-17 JUNCTION BOULEVARD  
CORONA, NY 11368**

**BULK  
ANALYSIS CHAIN OF CUSTODY**

Premise: 365 South End Ave Bldg # 400

# **ASBESTOS CONTROL PROGRAM EMERGENCY RESPONSE DIAGRAM**

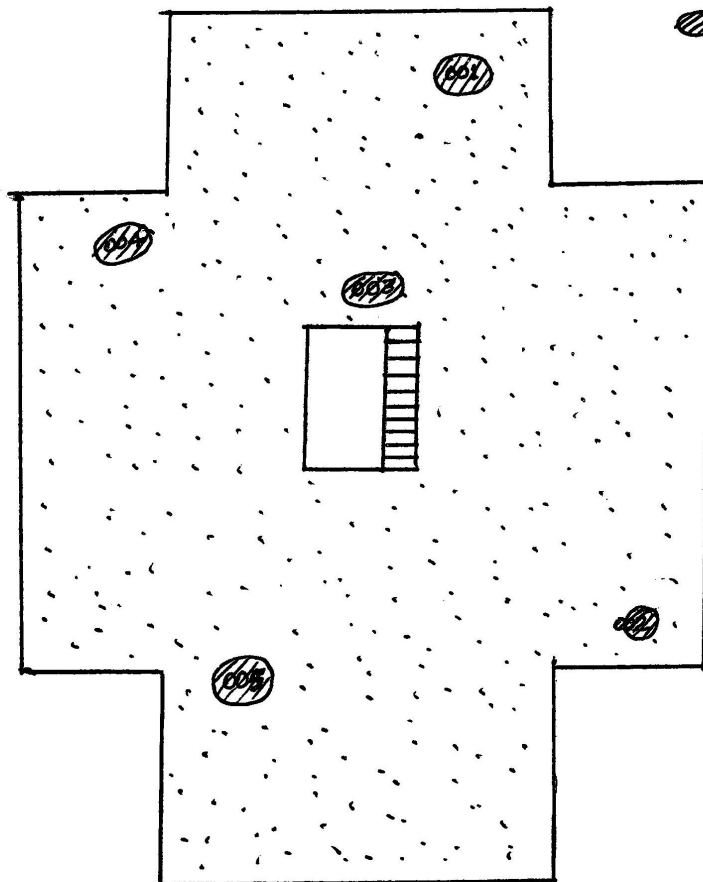
GRAVEL  
 SAMPLE LOCATION

- ☒ No Visible Debris
- ☐ Entire Roof Covered with Debris
- ☐ Partial Roof Covered
  - ☐ Local/Isolated Areas
  - ☐ Gutters
  - ☐ 25% of the roof
  - ☐ 50% of the roof
  - ☐ 75% of the roof

- \* Gravel on roof has been replaced <sup>after 9/11</sup> as per the super
- \* Mud like material observed below gravel.

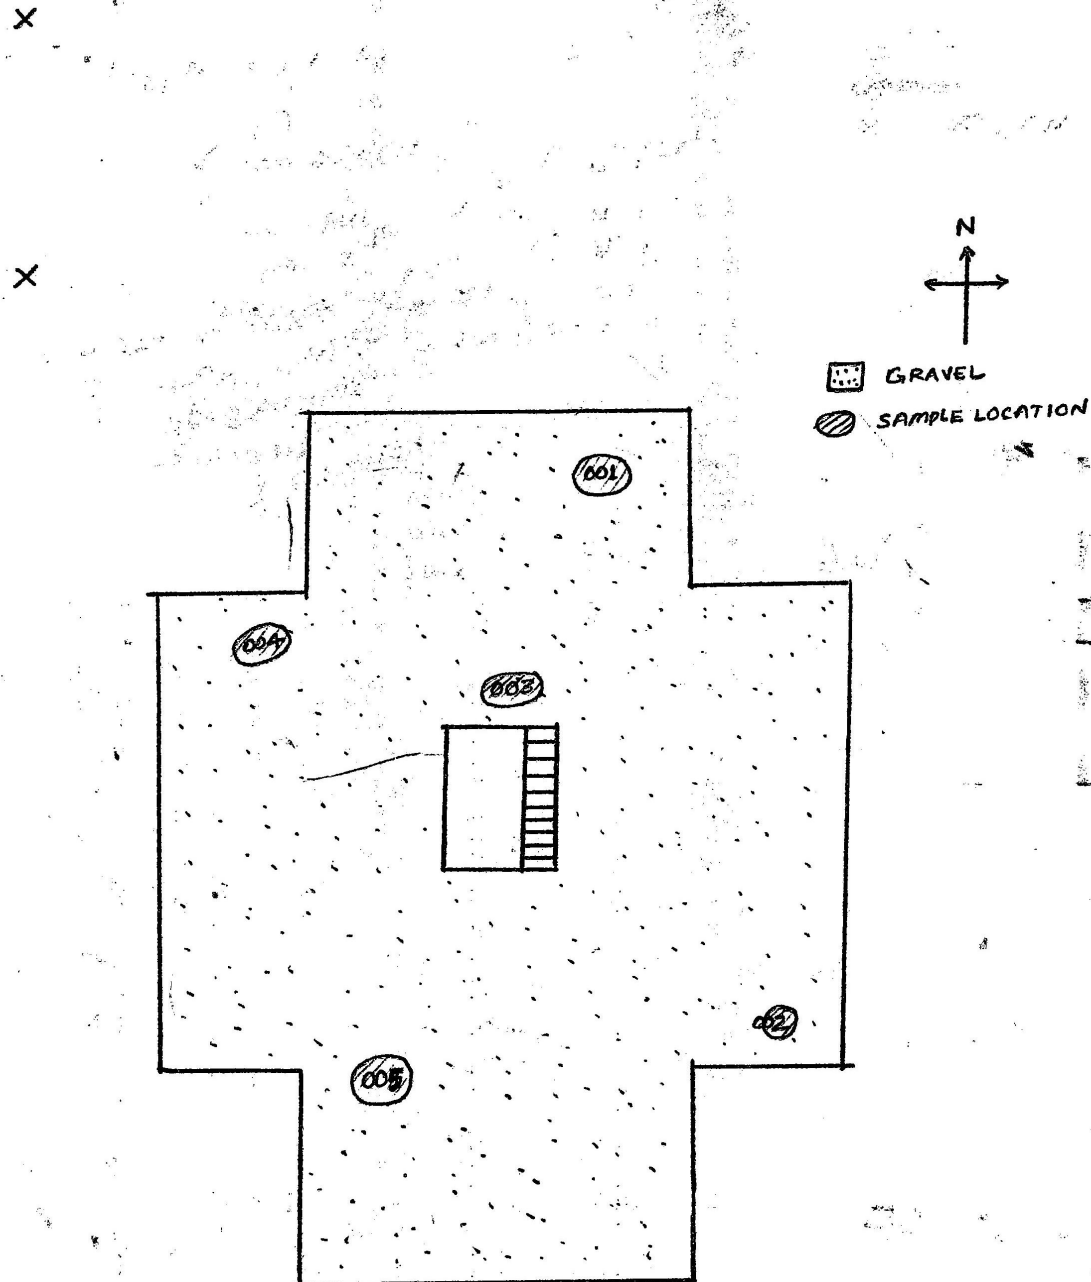
\* Gravel on roof has been replaced <sup>after 9/11</sup> as per the super  
\* Mud like material observed below gravel.
