## WTC Visual Survey Form

Premise Address: 94 Chamber Street

Date: 01/24/2002Inspection Team: Name: R. Fitzpatrick  
Name: R. RammelmanAgency: US EPA  
Agency: NYC DEP

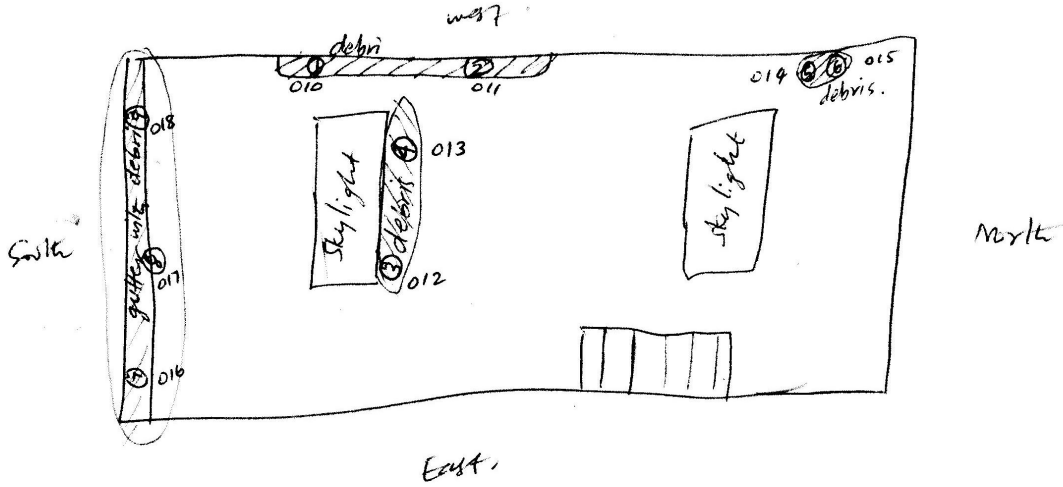
2/23 Inspected on roof access gained from 92 chamber roof. Roofs (multiple) access. Gutters still with debris as observed on 1/24/02
