**DEPARTMENT OF ENVIRONMENTAL PROTECTION  
BUREAU OF ENVIRONMENTAL COMPLIANCE  
ASBESTOS AND LEAD CONTROL PROGRAM  
59-17 JUNCTION BOULEVARD  
CORONA, NY 11368**  
JOEL A. MIELE, SR., P.E.  
COMMISSIONER

**BULK  
ANALYSIS CHAIN OF CUSTODY**

# WTC Visual Survey Form

Premise Address: 96-78-100 Chambers St.  
 Block: Residential ☐ Commercial ☐ Name of Building:  
 Lot: Mix Use ☒ Other ☐  
 # of Stories: AKA's:  
 Building Owner/Management: Frederick Moskowitz Telephone Number: (212) 732-4040  
 Name: Frederick Moskowitz FAX: (212) 212-234-1971  
 Address: P11 212-234-1971  
 On Site Contact: P11 Telephone Number: ( )  
 Name: P11  
 Building Owner Management Activities  
 Interior Survey Performed ☐ Yes ☐ No  
 Exterior Survey Performed ☐ Yes ☐ No  
 General Clean Up ☐ Yes ☐ No Locations: Some tenants cleaned up on their own  
 ACM Clean Up ☐ Yes ☐ No Locations:   
 Air Monitoring ☐ Yes ☐ No Locations:   
 Copies of All Reports and Data Requested ☐ Yes

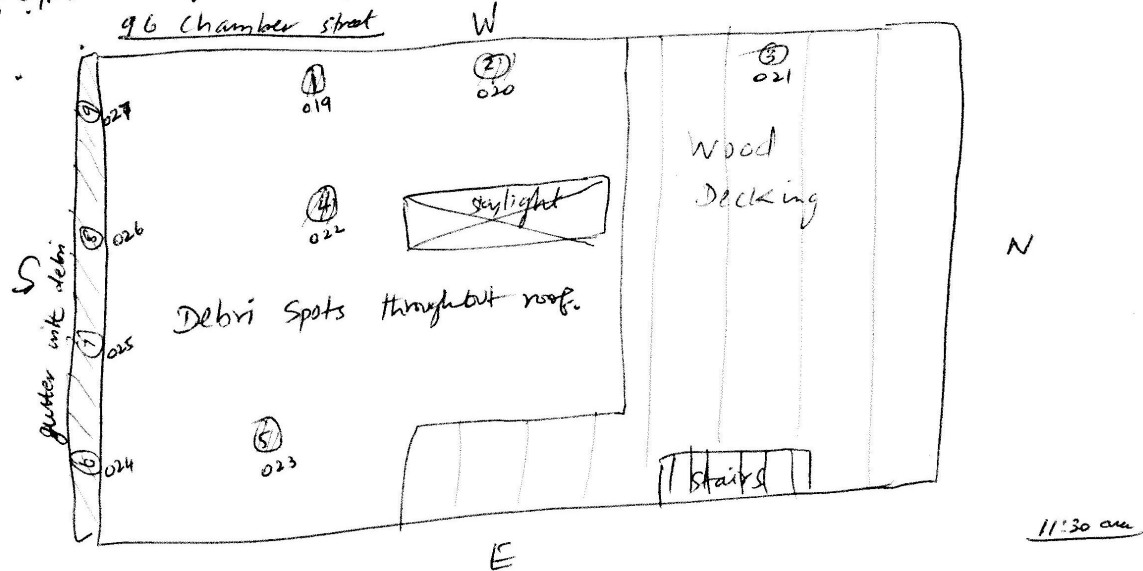
2/23/02 Roof debris appeared to be same as of Jan 24, 2002  
96 Chamber Street

Facade:  
 North ☐ N/A Inspected ☒ Yes ☐ No Debris ☒ No Visible/Fine Layer ☐ 1/2 to 1" ☐ > 1"  
 South ☒ N/A ☐ Yes ☐ No ☐ No Visible/Fine Layer ☐ 1/2 to 1" ☐ > 1"  
 East ☒ N/A ☐ Yes ☐ No ☐ No Visible/Fine Layer ☐ 1/2 to 1" ☐ > 1"  
 West ☐ N/A ☐ Yes ☐ No ☐ No Visible/Fine Layer ☐ 1/2 to 1" ☐ > 1"  
 Facade Description: Brick windows etc  
 Roof  
 Debris: ☐ No Visible /Fine Layer Light dust ☒ 1/2 to 1" of dust ☐ > 1" of dust.  
 Description: Debris on roof and in gutters. Could not get in back  
roofs to be inspected close up. Looks like what debris.  
 Setbacks N/A ☐  
 Floor:  Debris: ☐ No Visible/Fine Layer ☐ 1/2 to 1" ☐ > 1"  
 Floor:  Debris: ☐ No Visible/Fine Layer ☐ 1/2 to 1" ☐ > 1"  
 Floor:  Debris: ☐ No Visible/Fine Layer ☐ 1/2 to 1" ☐ > 1"  
 Floor:  Debris: ☐ No Visible/Fine Layer ☐ 1/2 to 1" ☐ > 1"  
 Floor:  Debris: ☐ No Visible/Fine Layer ☐ 1/2 to 1" ☐ > 1"  
 Comments: Need to contact owner and have him sample gutters

and other debris on roof

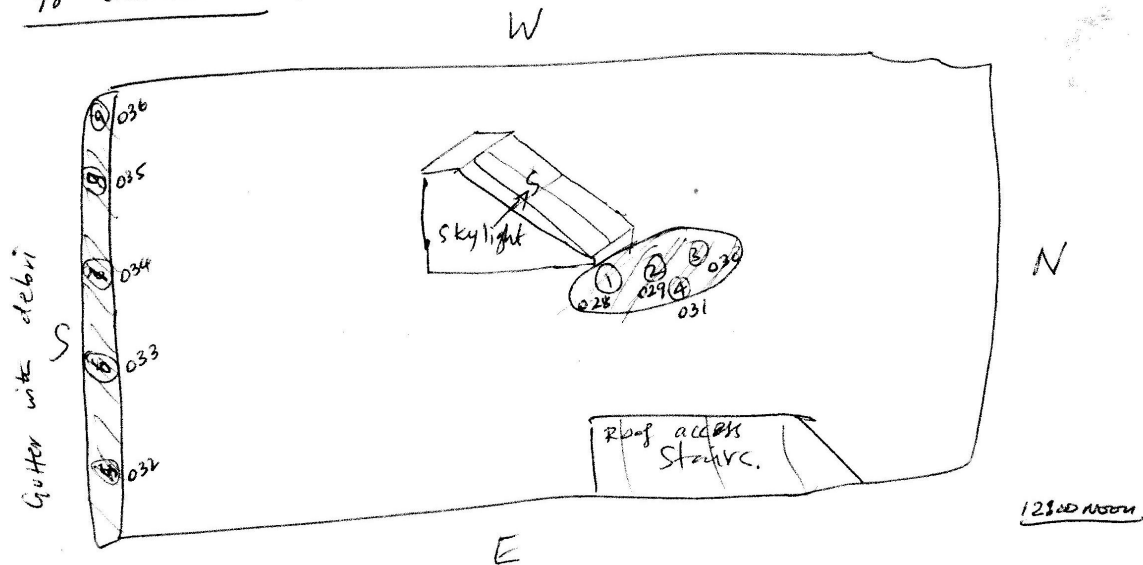
98 Chamber St : Roof debris still present as observed on 1/24/02

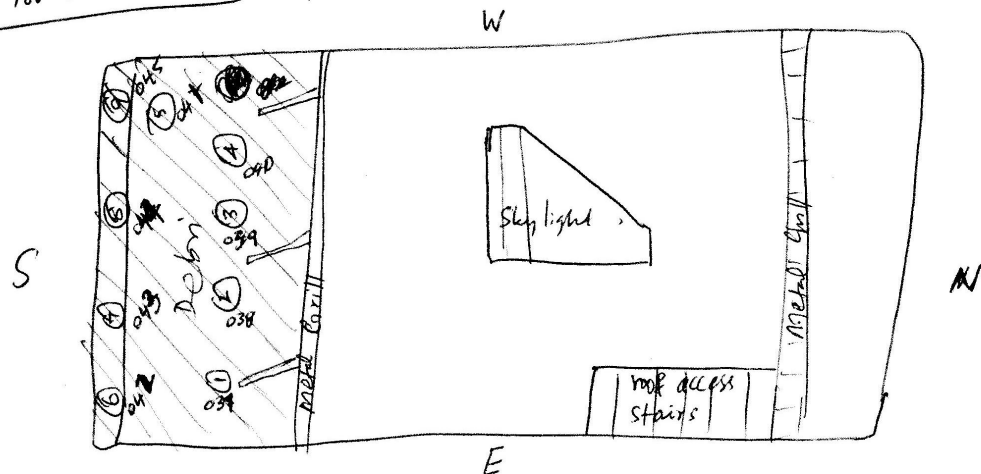
100 Chamber St. Gutters with some debris
