# WTC Visual Survey Form

| Premise Address: <u>97 Chambers Street</u> | | |

DEE & DEE

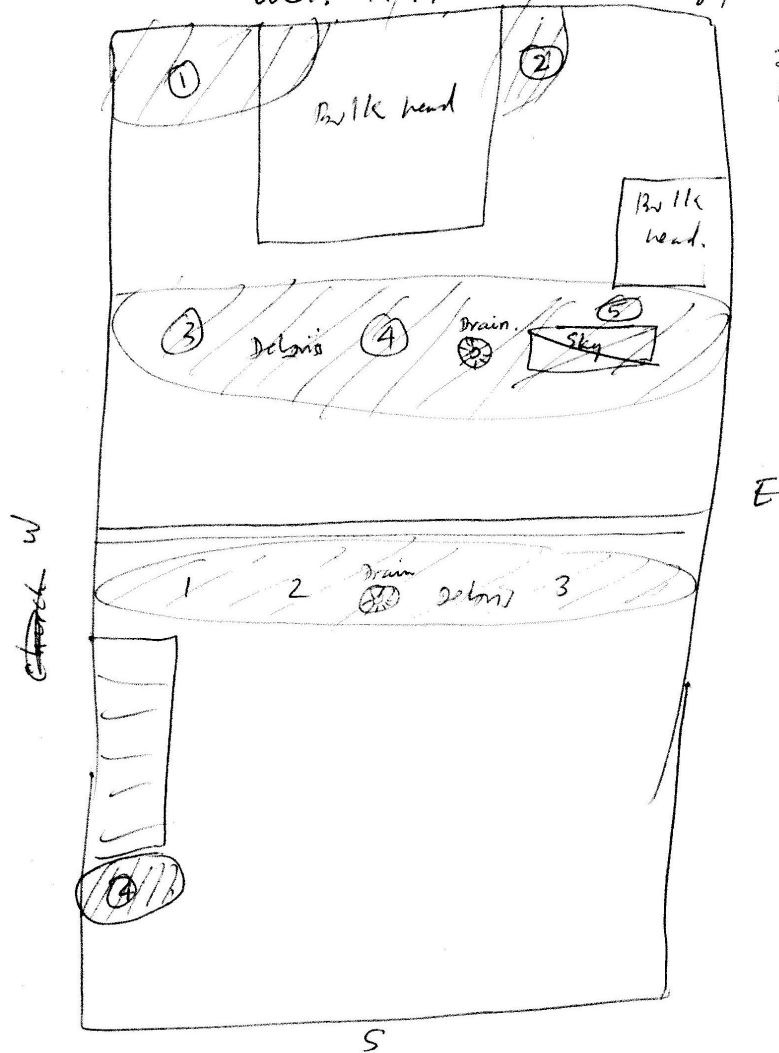
97 Chambers St.

Appeared to be one big roof  
But multiple roofs.
