**ASBESTOS CONTROL PROGRAM  
EMERGENCY RESPONSE  
DIAGRAM**

| <p><b>NAME</b> <u>173 L. REYNA</u> <b>BADGE #</b> <u>A055</u></p> <p><b>LOCATION</b> <u>173 BROADWAY</u></p> | <p><b>DATE</b> <u>2/27/02</u></p> <p><u>2:30 pm</u></p> |

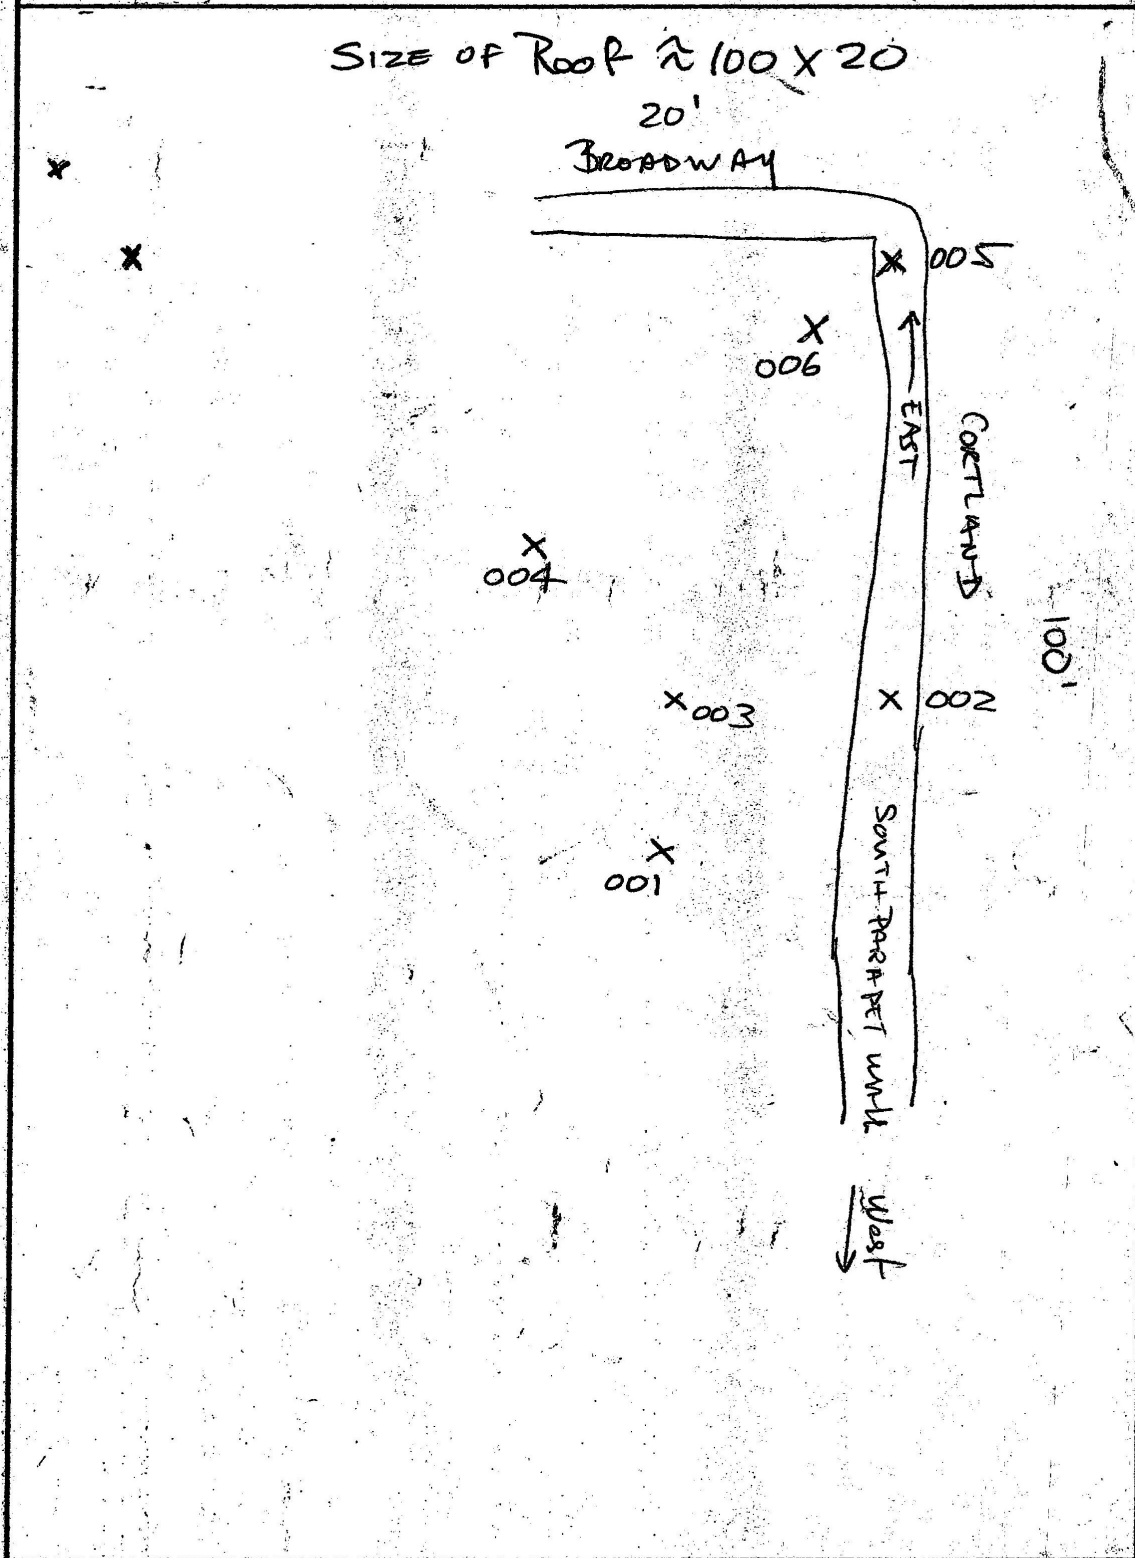
☒ Partial Roof Covered

☒ 25% of the roof

Size of Roof  $\approx 100 \times 20$
