**Re: Bulk Dust Sample Results for 130 Cedar Street, New York, NY.**

**JLC Environmental Consultants, Inc. (JLC)** was authorized to proceed with a survey to determine the presence of Asbestos Containing dust at the above-mentioned location.

JLC Project No. 04-3271

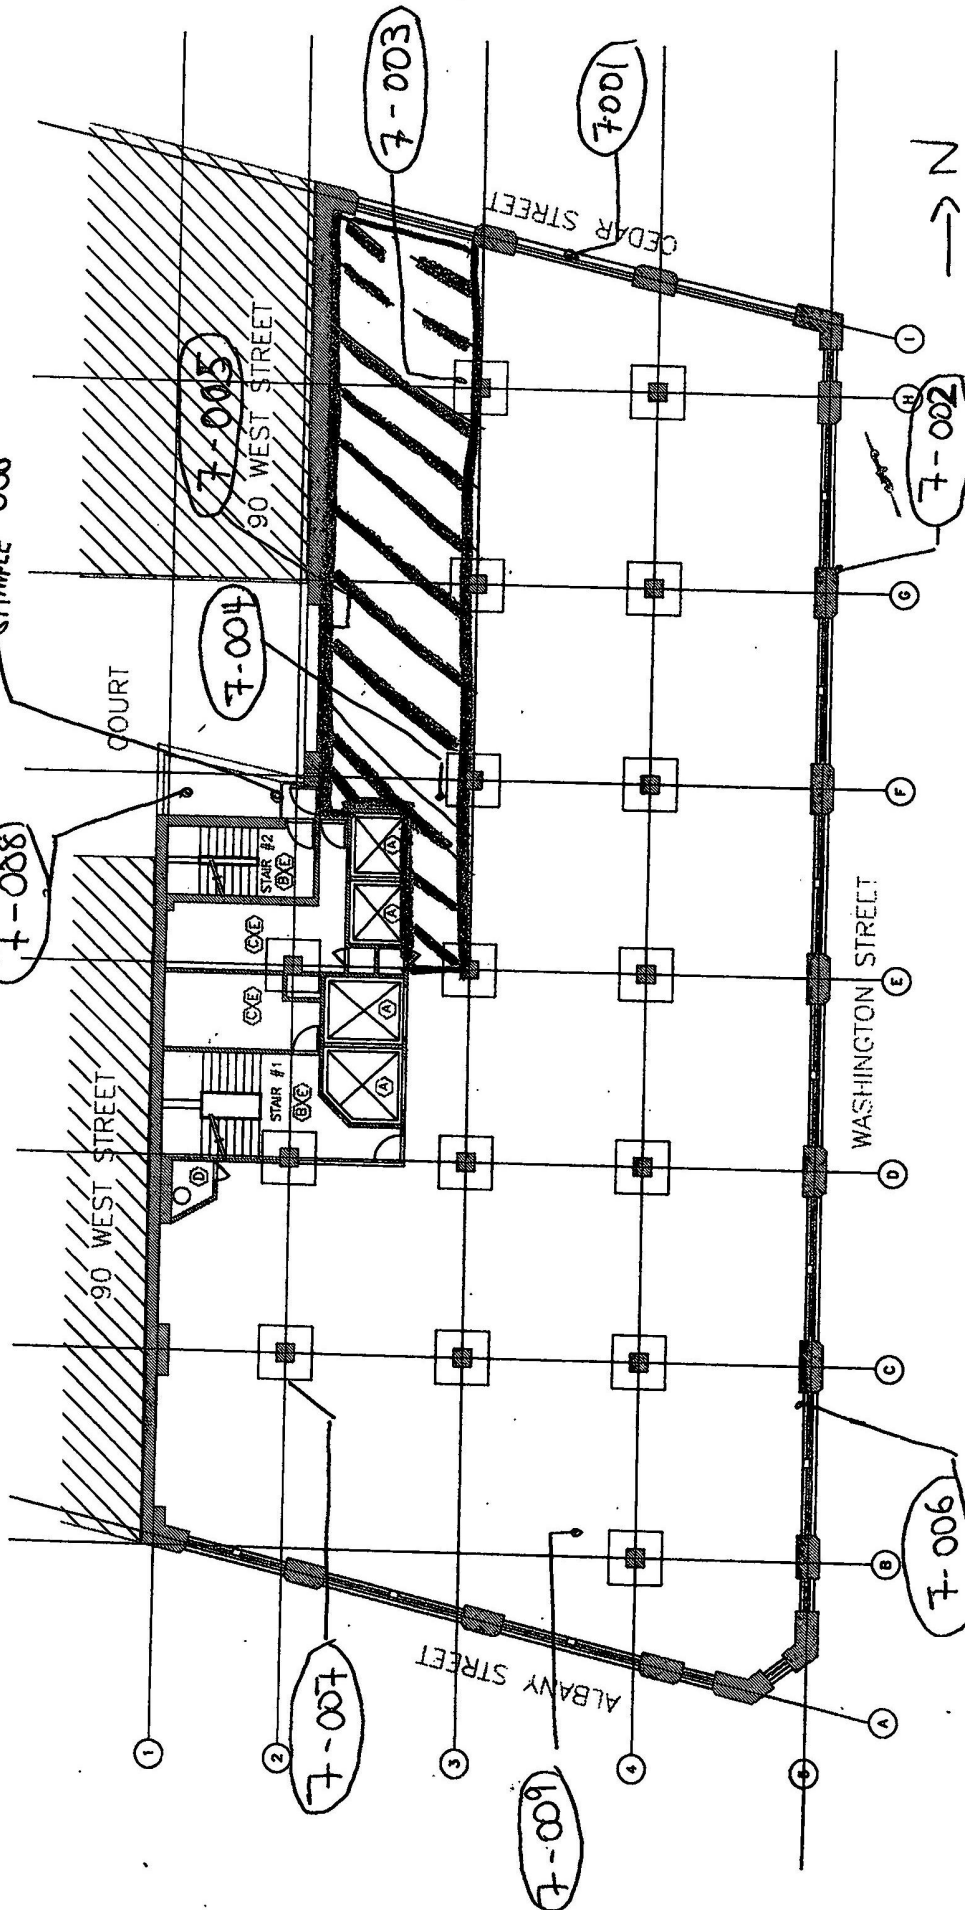
130 CEDAR - ACM SAMPLE LOCATION PLAN

| SAMPLE LOCATION | HA | SUSPECT ACM | SAMPLE NO | POSITIVE SAMPLES | SAMPLES WITH <1.0% ACM | FINAL CLASSIFICATION | NOTES |
|---|---|---|---|---|---|---|---|
| 7 <sup>th</sup> Floor | B | | 004-008 | 004B | N/A | Confirmed ACM in poor condition-approx. 1,500 SF | |

DATE 12/02/04  
INSPECTOR: PETER LUDWIG  
Approx 1,500 SF Skimcoat in  
poor condition See page 2  
of report (Samples 004-008)

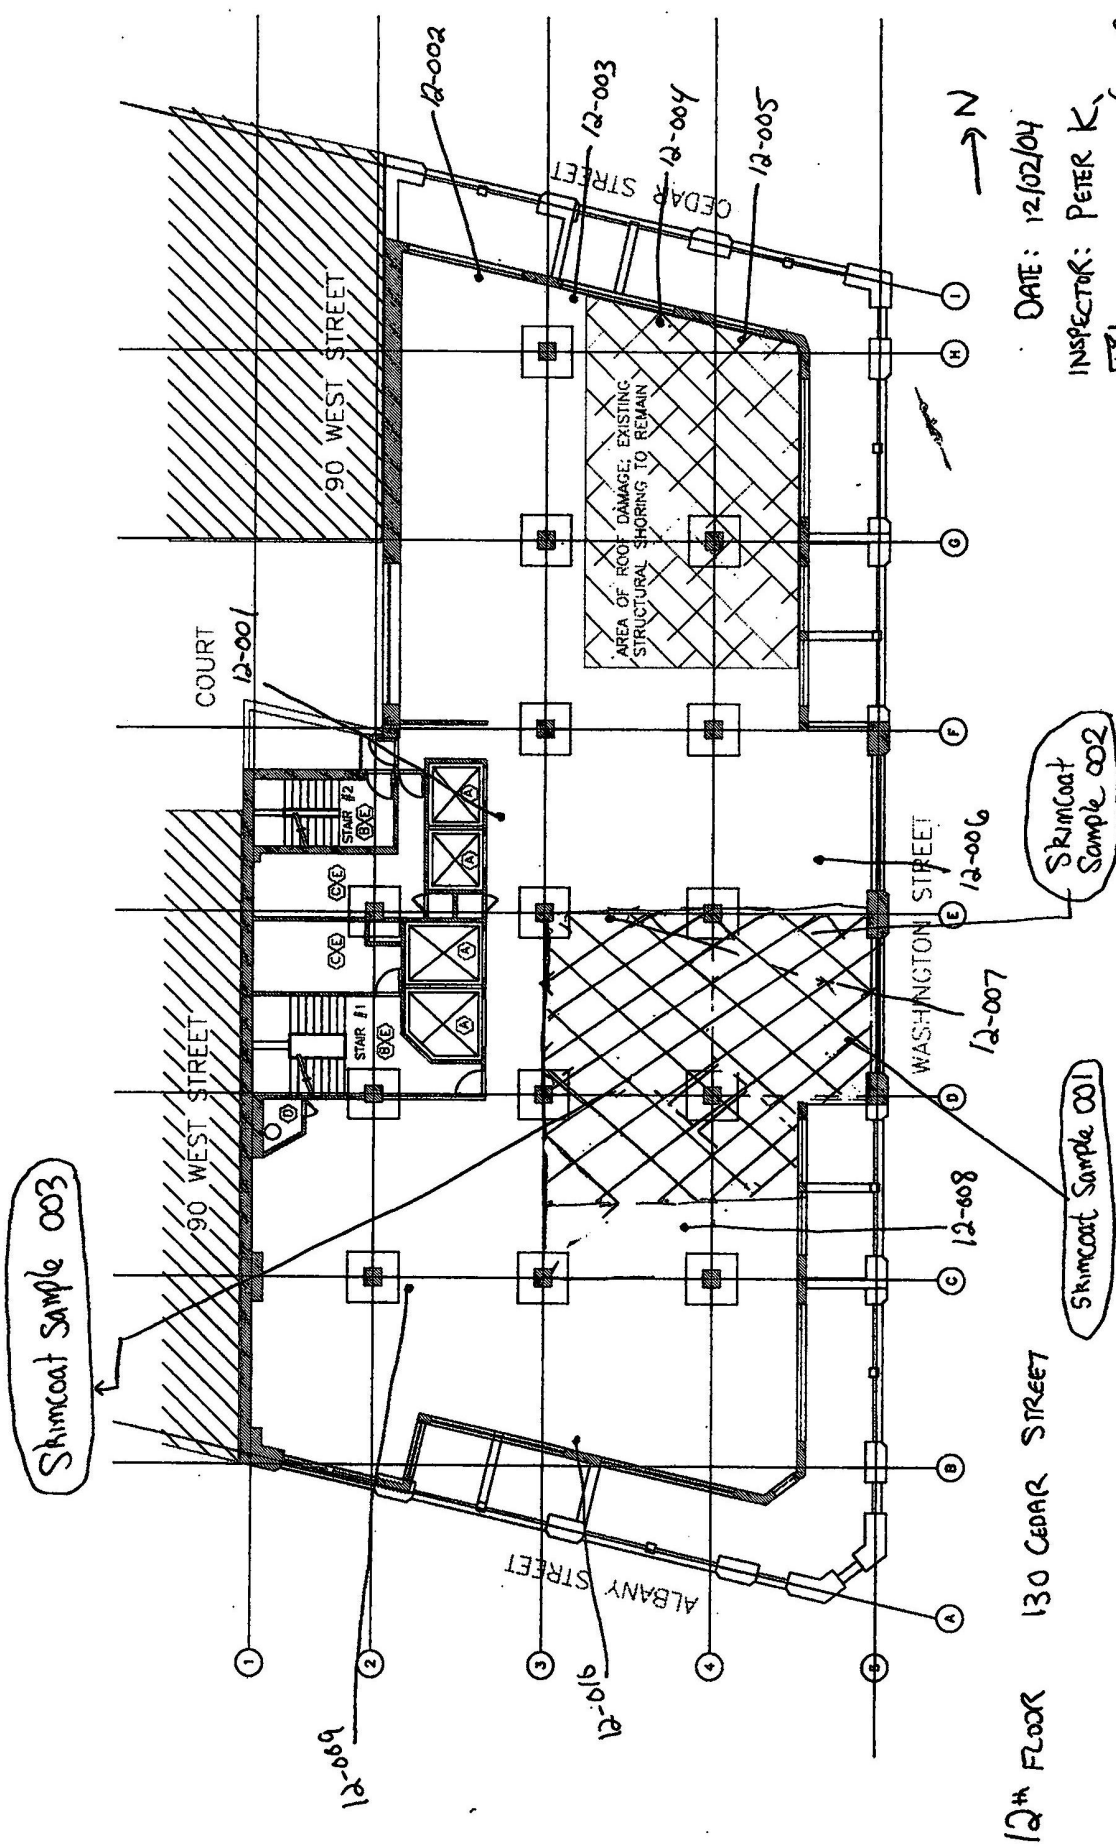
DATE: 12/02/04  
 INSPECTOR: PETER K.  
 AREA (approx) of confirmed ACM Shimcoat on ceiling

Exterior Sample 007 of mortar on parapet
