Intrepid Museum-Pier 86

**Project:** Intrepid Museum  
New York, New York

**Subject:** Compressive Tests of Concrete Cores.

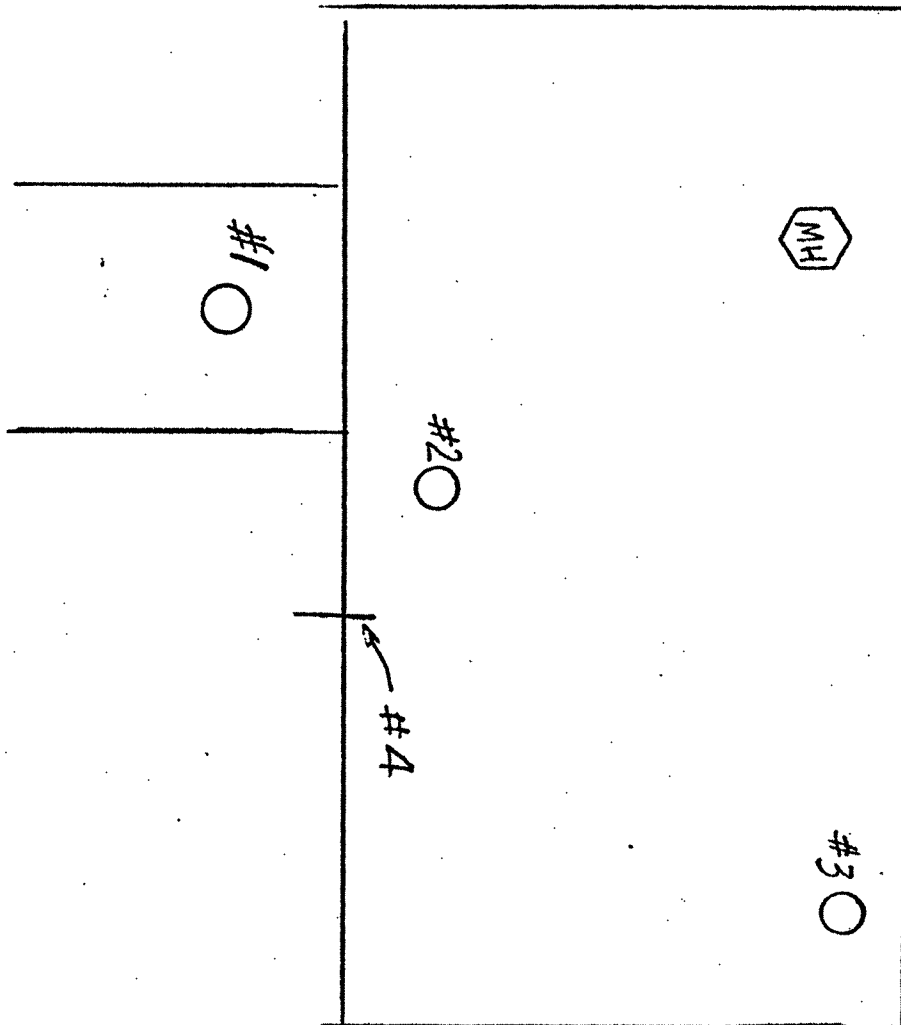
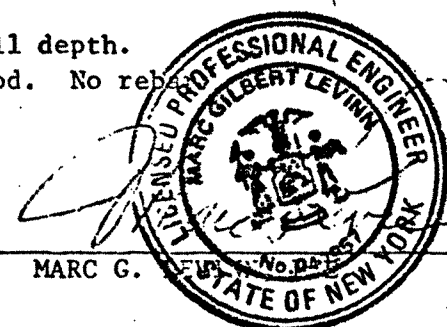
KEY PLAN OF CORES - OUR FLOW  
at 46th ST - INTERIOR MUSEUM

You will find attached a concrete core report,  
including a location plan for the four cores taken.

Cores No. 2, 3 and 4 were made into the slab and  
walls of the twin barrel sewer that runs along the  
centerline of Pier 86 in the immediate vicinity of  
the proposed entrance/utility building serving the  
USS Intrepid Museum activities. They indicate  
compressive strengths of 2896, 3846 and 3891 psi.

Core No. 1 was taken to establish the soundness  
of the concrete in the existing pier that will sup-  
port a significant portion of the proposed building.  
The 3846 psi compressive strength found is satis-  
factory for the purpose of our design.
