**DEPARTMENT OF ENVIRONMENTAL PROTECTION  
BUREAU OF SEWERS**

DSM #83-114D

REPORT FOR THE RECORD

RE: W.T.C. 776 Dey Street Escalator Underpass at  
Church Street, Borough of Manhattan

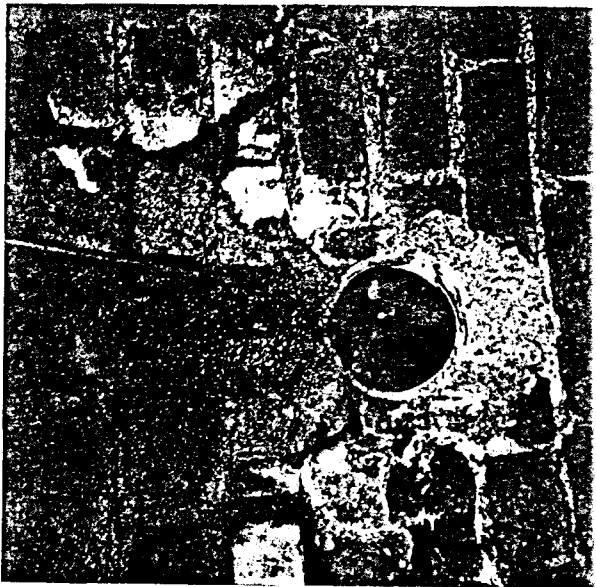
Both 4" vit. spurs (see photos #1, #2, & sketch #1) were observed at m.h. #2 as shown on sketch #1. They were both located 26" apart on the south face of this sewer manhole. 'Spur' 'X' showed definite indication of having a flow (miniscule amount of debris in pipe at this visit - 2:00am), and is therefore connected and alive. The source of flow in this 4" connection could not be readily ascertained, however it is speculated that the connection was made at a non-public service utility of the E.N.Y. Savings Bank which is located on the south west corner of this intersection. The other spur remains as shown in picture #2 is unconnected.

4" VIT "SPUR" SHOWING H<sub>2</sub>O RESIDUE - CONNECTION WAS MADE AT THIS POINT. (CHUCK - UG 41.11mm) #1

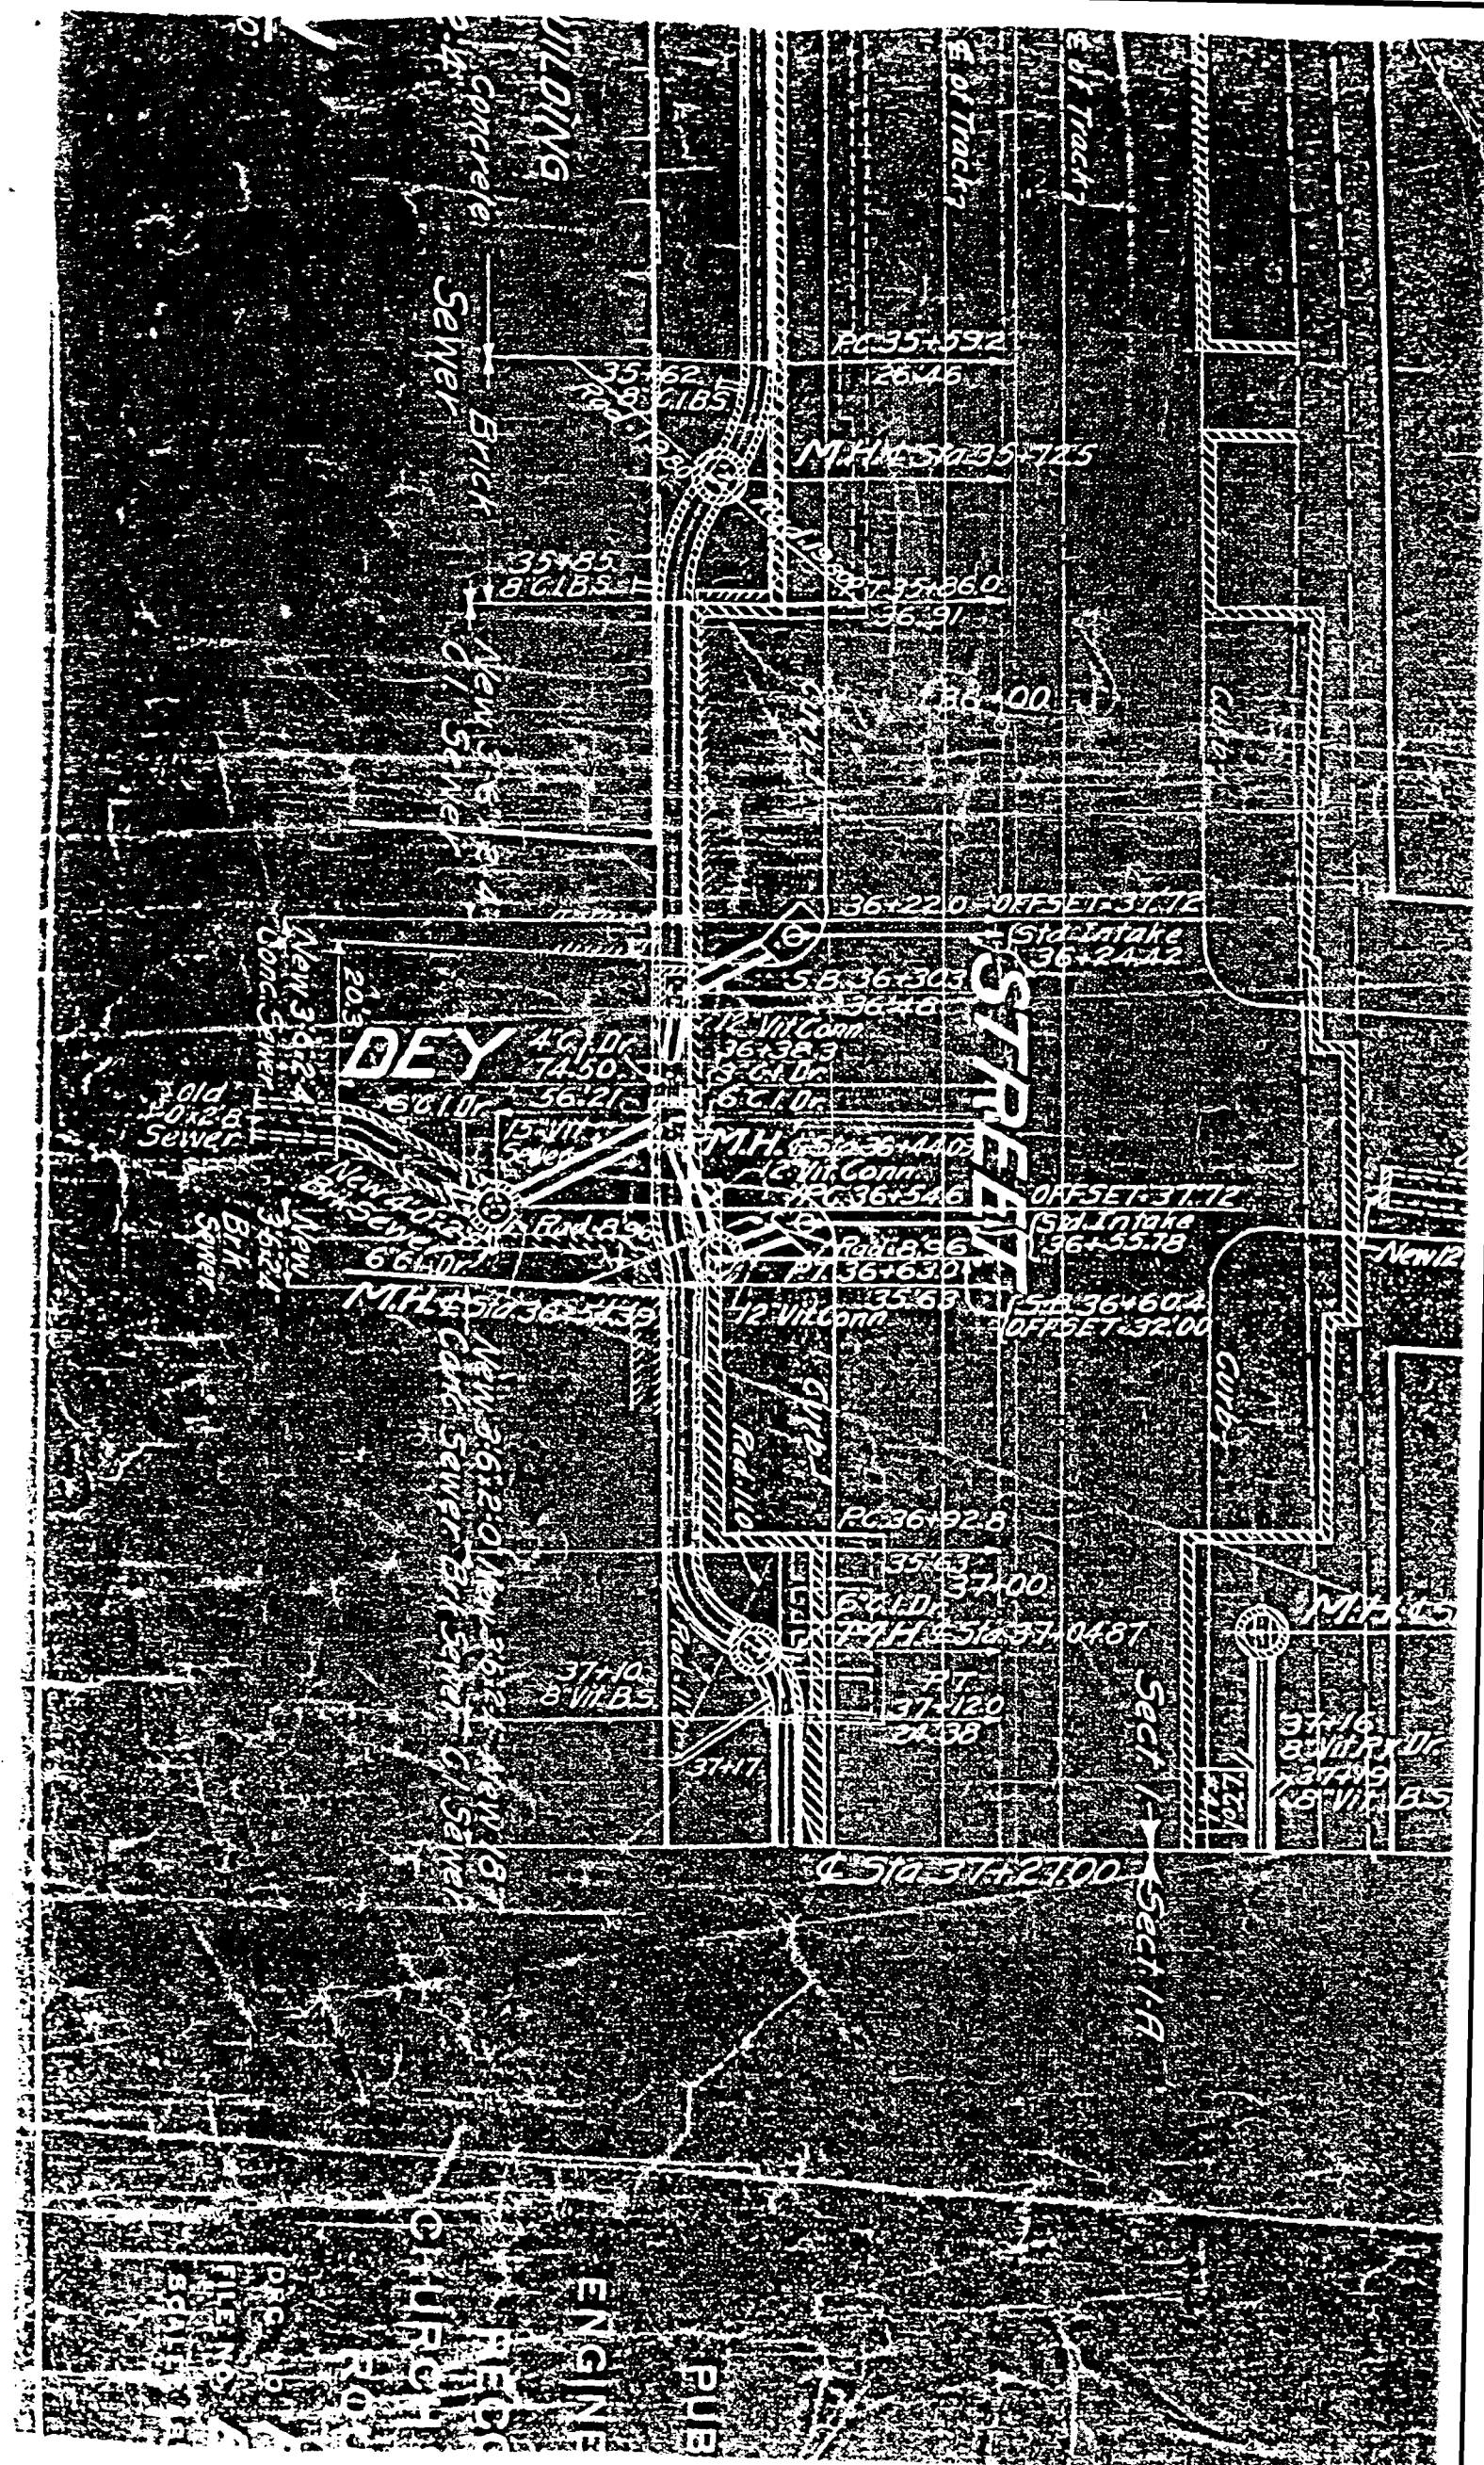
**SKETCH #1**

4" VIT. SPURS AT  
MH # 2 (SEE SKETCH #2)

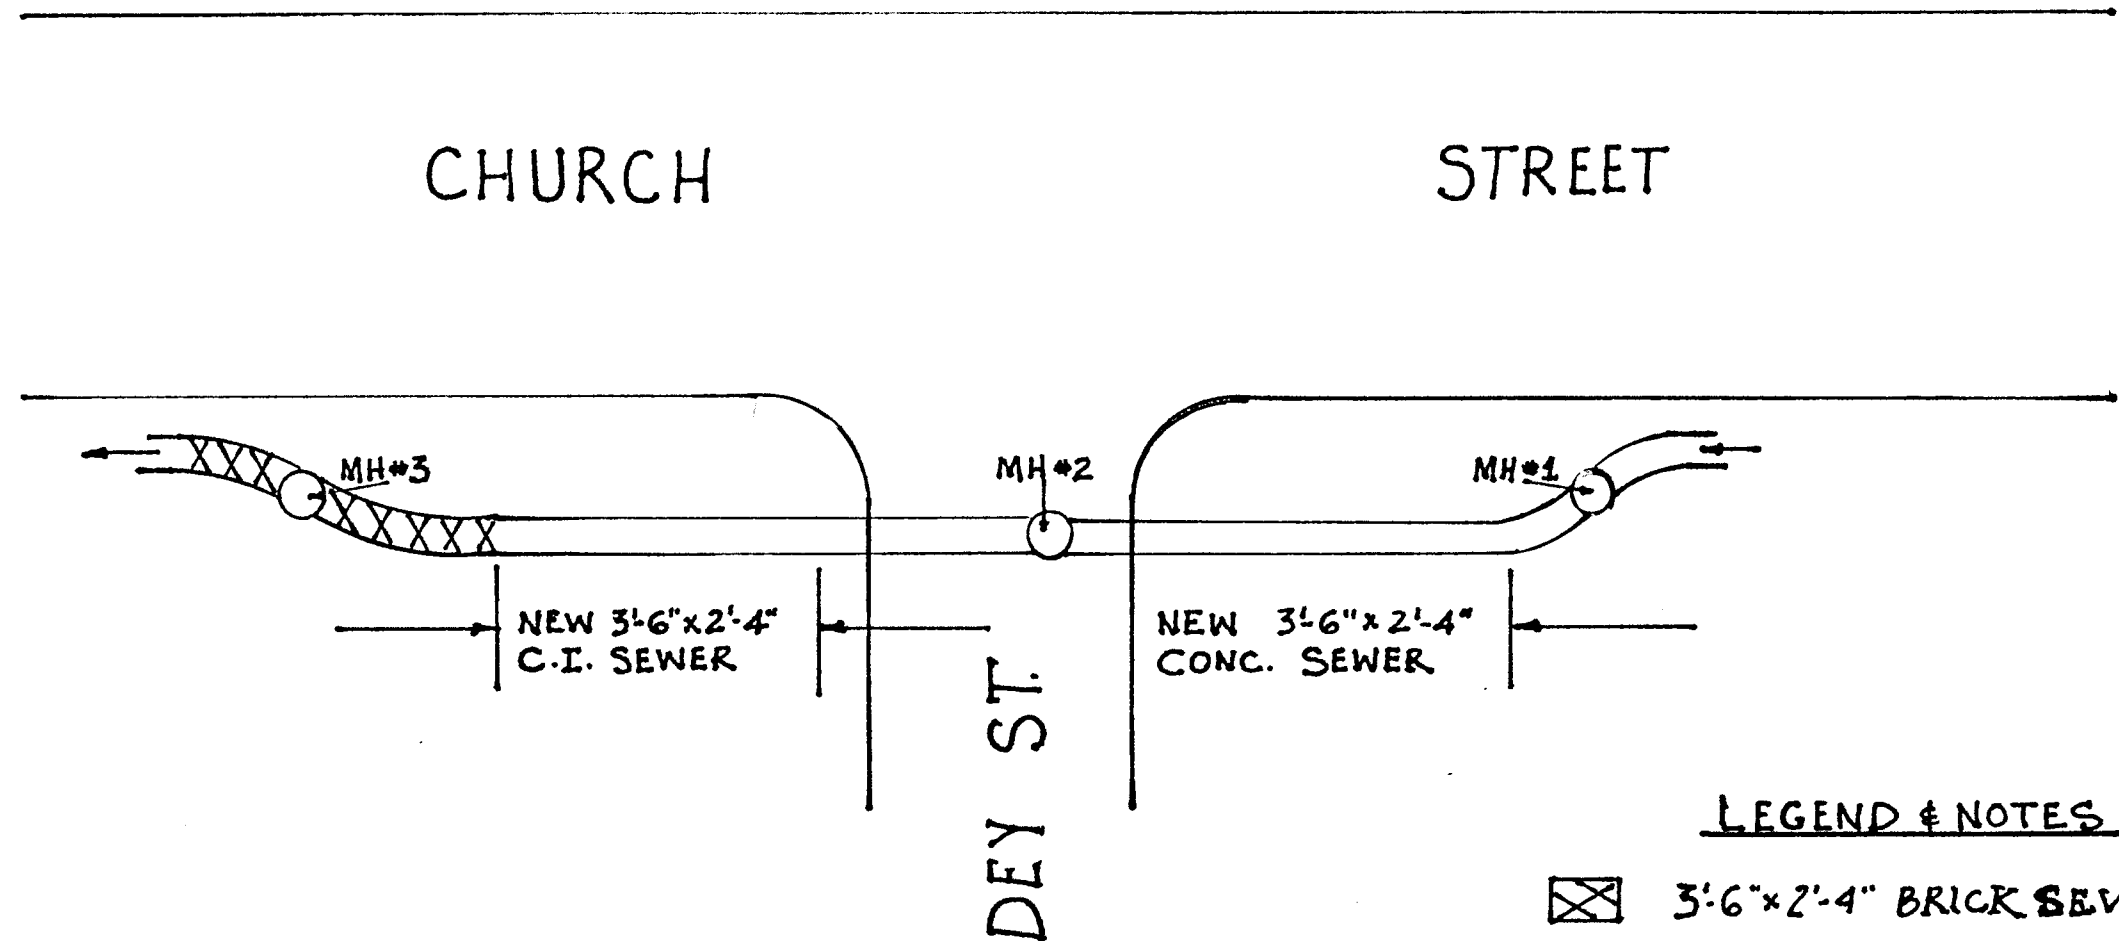
SKETCH #2

1. ALL SEWER SECTIONS ARE ELLIPTICAL.
2. BOTH M.H. #2 & #3 ARE DETERIORATED - MULTIPLE CRACKS.
