WTC EMERGENCY - CITY OF NEW YORK  
STRUCTURAL ENGINEERING ASSOCIATION OF NEW YORK

## DETAILED BUILDING EVALUATION SAFETY ASSESSMENT FORM

ADDRESS 200 VESEY STREETZIP CODE 10281NUMBER OF STORIES 50"FOOTPRINT AREA" (sq ft) 88400.181PLACENAME / ADDRESS 2 Tower G and WintergardenCONTACT ROBERT F DAUER

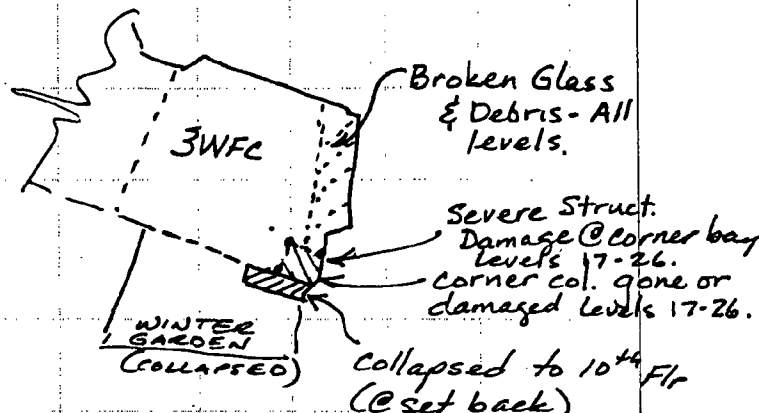
☐☐☒S.E. Corner Bay, 17<sup>th</sup> to 26<sup>th</sup> Fls., 1 to 10

☐☐☒@ S.E. Corner Bay. Holo @ 18<sup>th</sup> Fl, Cracks @

☐☐☒SE. Corner col. missing/damaged. All others OK. 17-2

① The S.E. Corner bay, (17 to 20) has beams that are sloping up to 1/2" per ft. 18<sup>th</sup> Flr slab is missing, column has marginal E-W restraint @ that level. Level 17 is holding without sign of distress, but debris loads from levels above are significant. DEBRIS HAS BEEN STABILIZED Temporarily.

② THE SE Corner (Levels 1-10) is completely collapsed. Remaining perimeter E-W beam is ~~not~~ warped @ bottom flange. Connections are intact.

☐ Other recommendations: ① Remove damaged structure @ SE Corner, one corner bay, levels 18 to 26. Currently that structural bay is cantilevering from remaining columns, which is <sup>very</sup> unsafe. Columns currently appear to be carrying the load OK.

COMMENTS: ② Remove SE Corner remaining slabs where hanging on.

Evaluate capacity of remaining perimeter beam to be repaired.
