# ***Interim Final WTC Residential Confirmation Cleaning Study***

**Volume 1**

110 Liberty St.  
New York, NY

**U.S Environmental Protection Agency, Region 2**  
New York City Response and Recovery Operations

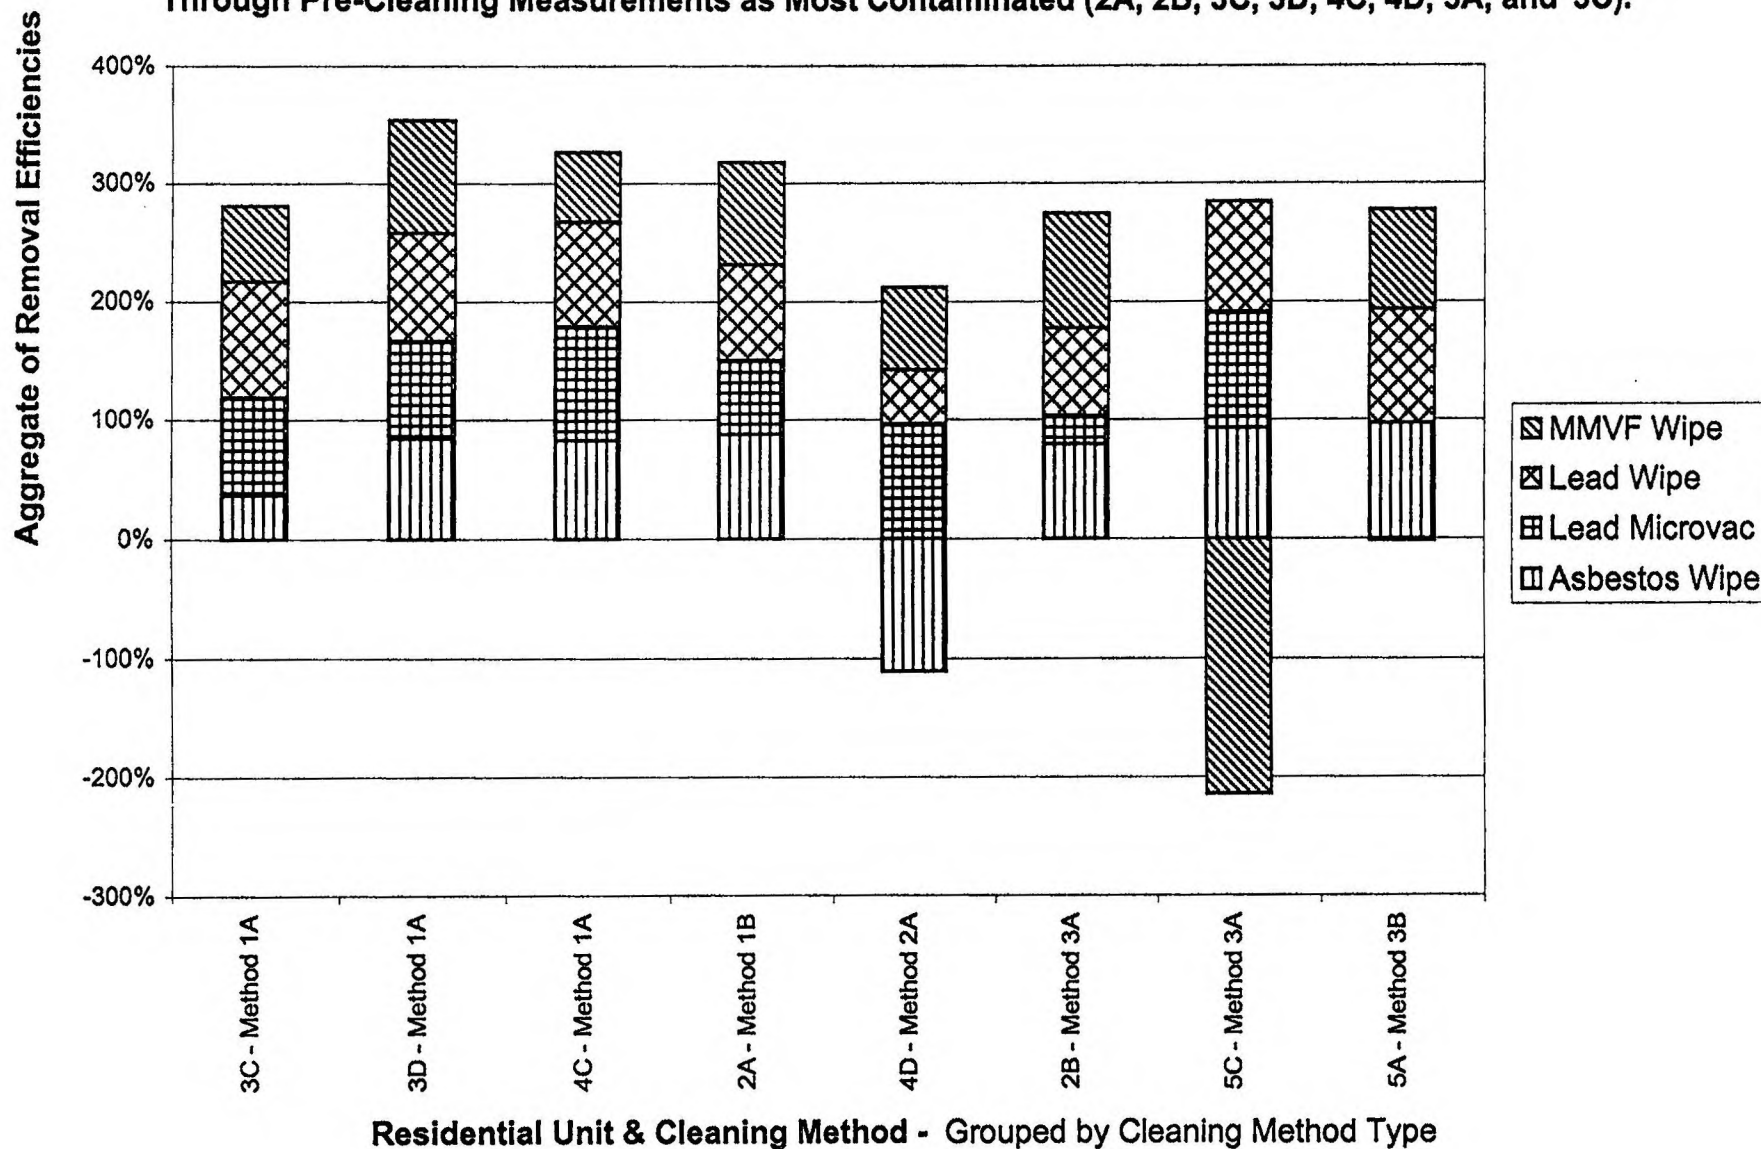
**Figure 1. Contaminant Removal Efficiency After the First Cleaning Attempt of Units Identified Through Pre-Cleaning Measurements as Most Contaminated (2A, 2B, 3C, 3D, 4C, 4D, 5A, and 5C).**

**The study demonstrated that use of a standard cleaning method of vacuuming and wet wiping significantly reduced levels of WTC-related contamination with each cleaning event and was successful in reducing concentrations to levels below health-based benchmarks.**
