## Acknowledgments

The United States Environmental Protection Agency (EPA) is grateful for the generous contribution of Mr. David M. Baldwin of Liberty Street Associates, LLC for his generosity in providing 110 Liberty Street as the study building.

This project was designed by EPA with the support of the Indoor Air Work Group of EPA's Interagency Indoor Air Task Force. The efforts of the task force were essential to successful implementation of the study. The work group organizations directly involved in the development of the project included: the Federal Emergency Management Agency; the New York City Department of Environmental Protection; the New York City Department of Health and Mental Hygiene; The City of New York Mayor's Office of Environmental Coordination; the New York City Office of Emergency Management; the New York State Department of Health and Mental Hygiene; the Agency for Toxic Substances and Disease Registry; the Occupational Safety and Health Administration; EPA's Office of Solid Waste and Emergency Response, and EPA Region 2.

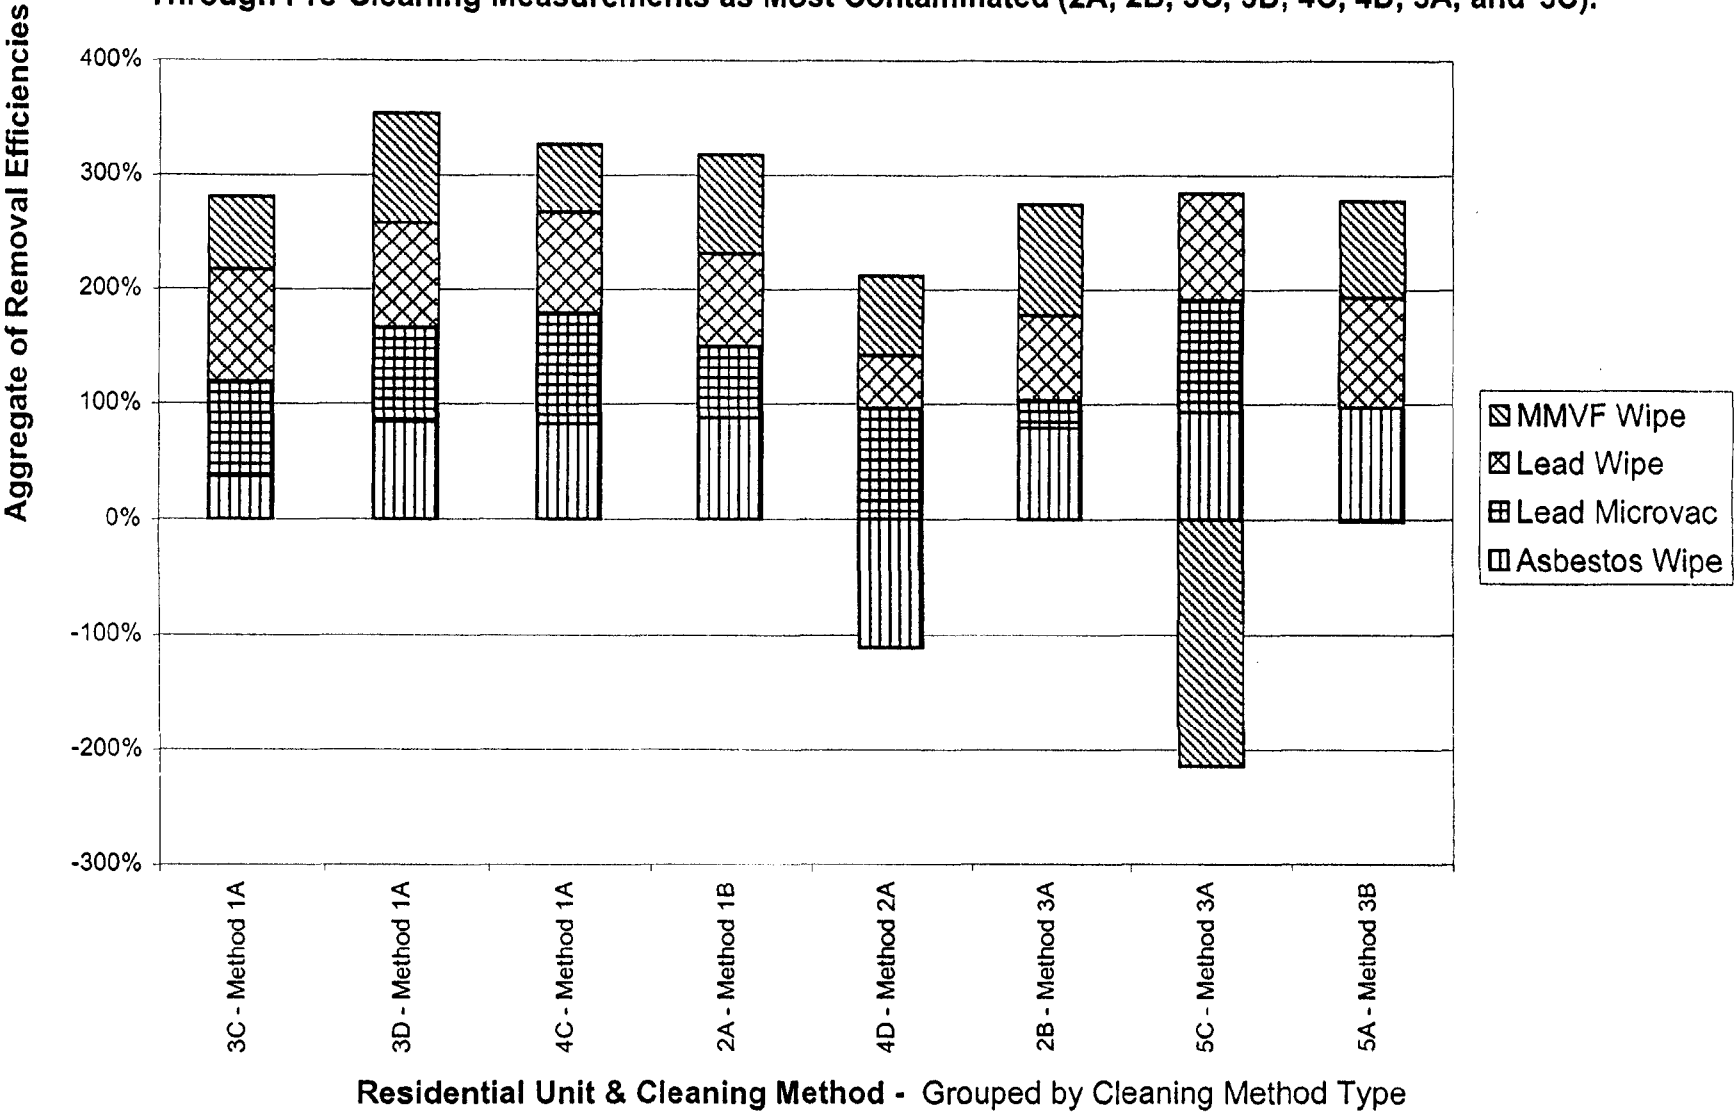
**Figure 1. Contaminant Removal Efficiency After the First Cleaning Attempt of Units Identified Through Pre-Cleaning Measurements as Most Contaminated (2A, 2B, 3C, 3D, 4C, 4D, 5A, and 5C).**

**5.**  
**The study demonstrated that use of a standard cleaning method of vacuuming and wet wiping significantly reduced levels of WTC-related contamination with each cleaning event and was successful in reducing concentrations to levels below health-based benchmarks.**
