**SUMMARY REPORT:**

**CHARACTERIZATION OF PARTICULATE  
FOUND IN APARTMENTS  
AFTER DESTRUCTION OF THE WORLD TRADE CENTER**

Eric J. Chatfield, Ph.D.  
Chatfield Technical Consulting Limited  
2071 Dickson Road  
Mississauga, Ontario, Canada L5B1Y8  
(905) 896.7611

John R. Kominsky, M.Sc., CIH, CSP, CHMM  
Environmental Quality Management, Inc.  
1800 Carillon Boulevard  
Cincinnati, Ohio 45240  
(513) 825.7500

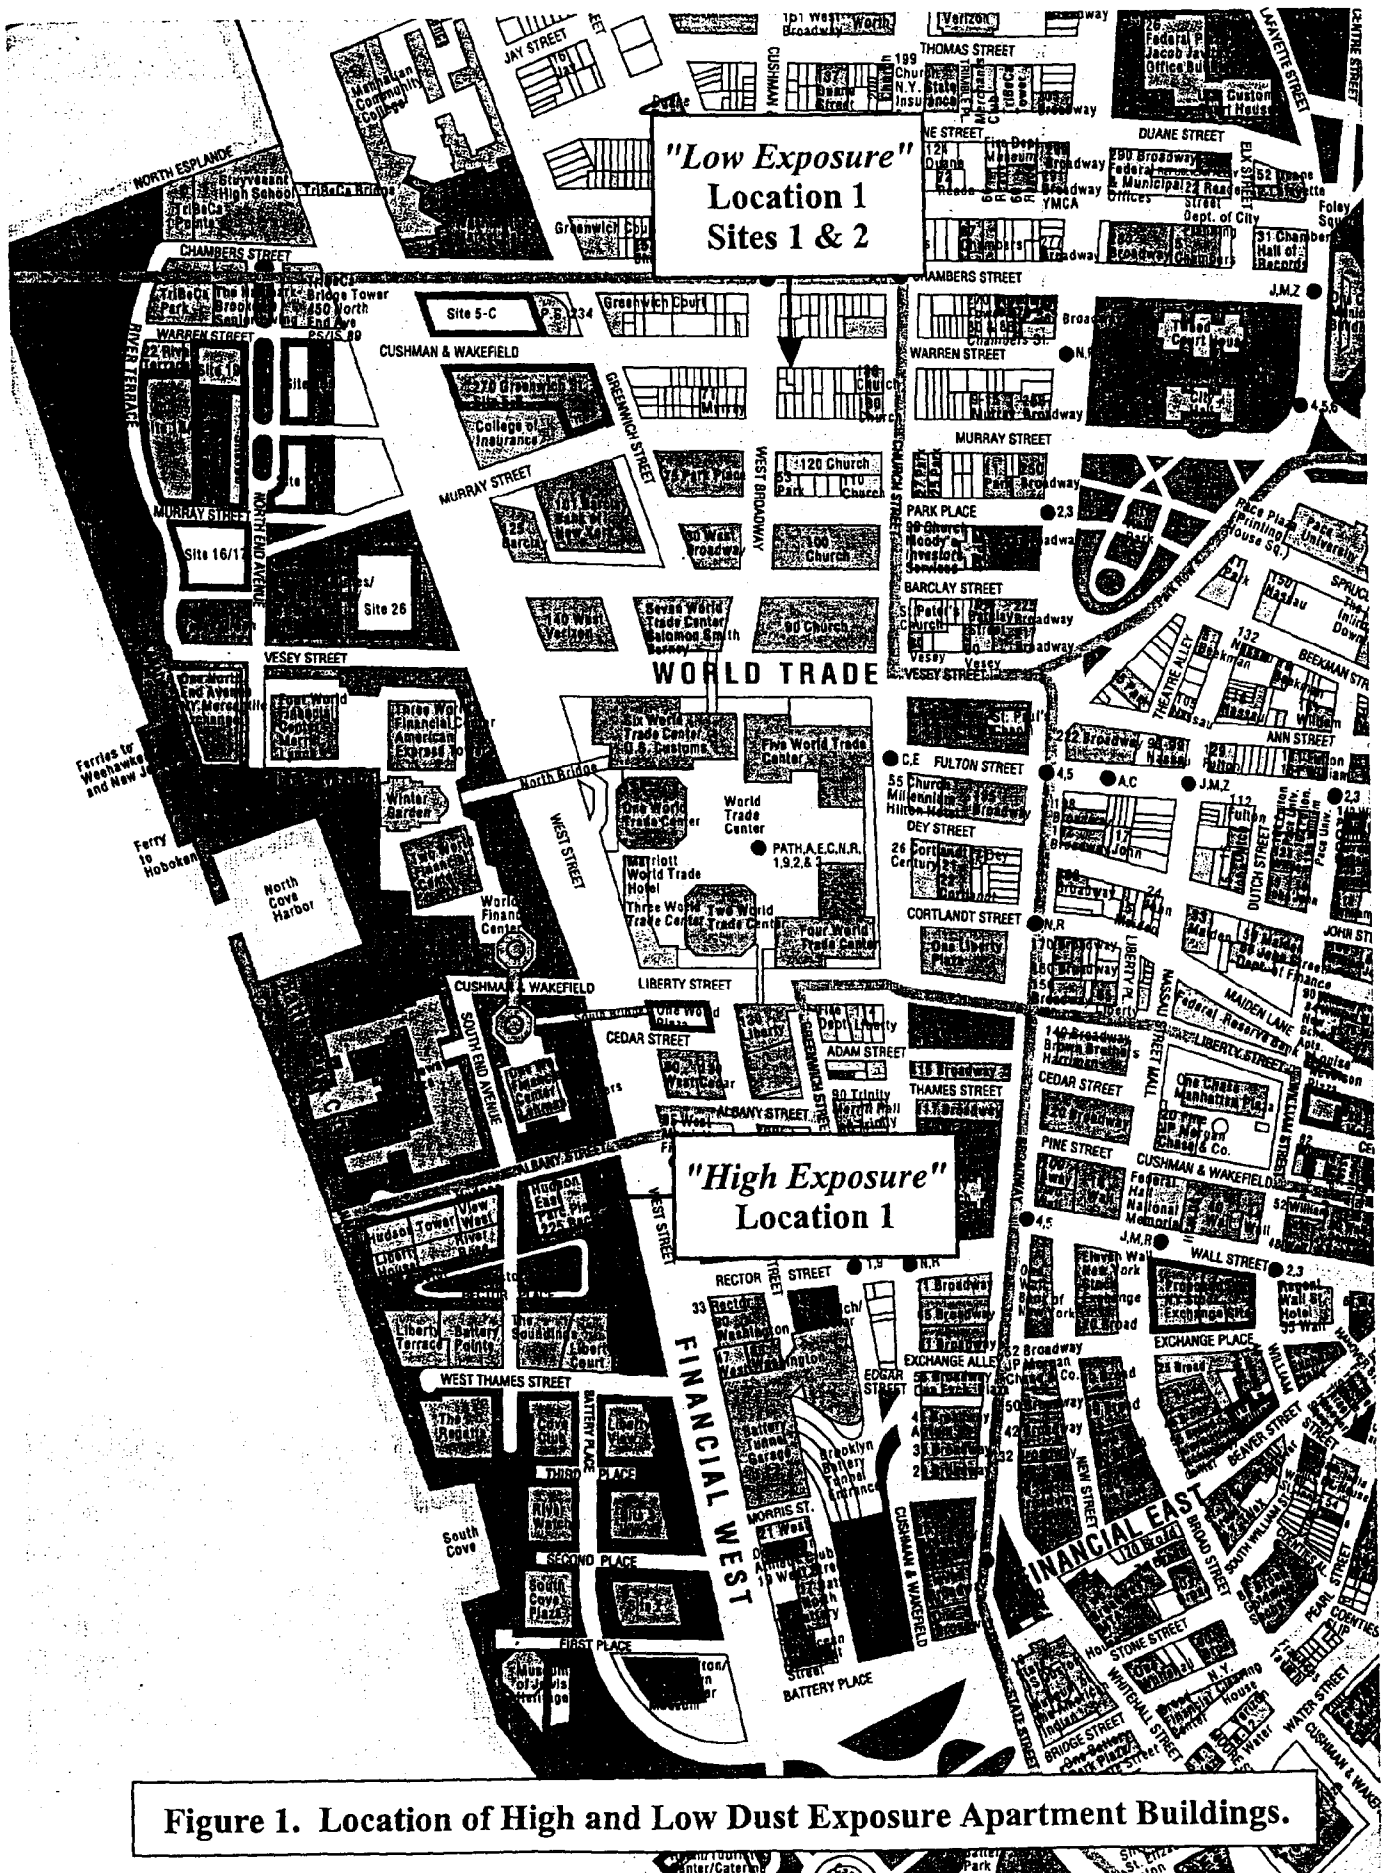
Figure 1. Location of High and Low Dust Exposure Apartment Buildings.

As shown in Figure 1, the high exposure 30-story apartment building is situated on South End Avenue, close to and southwest of Ground Zero. ~~Windows of several apartments on the upper levels had been broken,~~ but the building showed no other signs of external damage. This building was selected for study because it appeared to be the nearest one to Ground Zero that had electrical power available for operation of air sampling pumps. Apartment 10D on the
