INDOOR AIR QUALITY SURVEY

COLLEGIATE CHURCH CORPORATION

45 John Street, Suite 1000, New York, NY

February 12, 2002

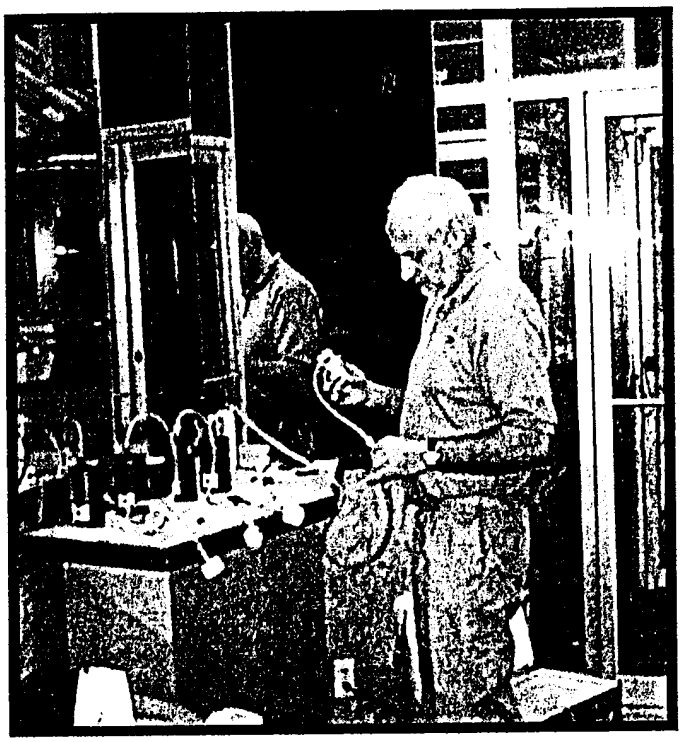
Photo 1: Air sampling location in the first floor lobby of 11 John Street.

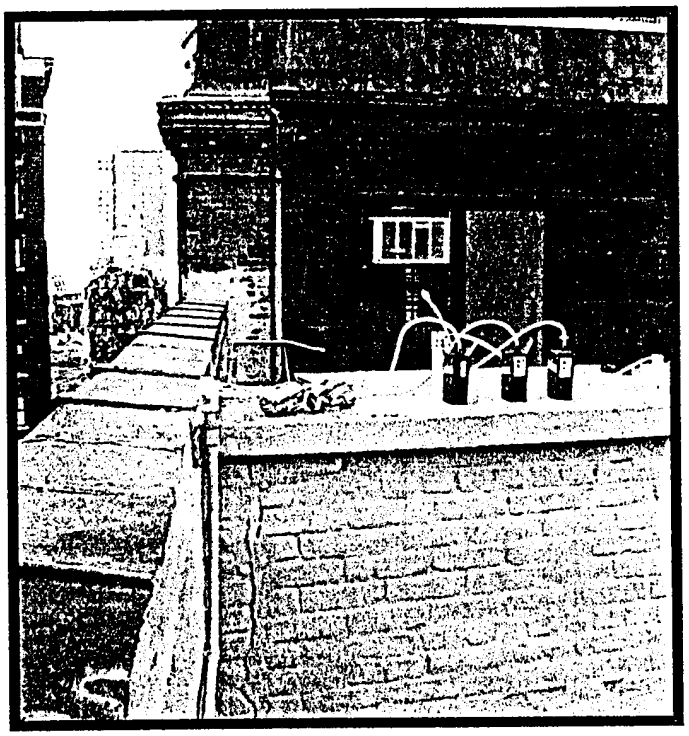
Photo 2: Air sampling location at the southwest corner of the roof of 11 John Street.

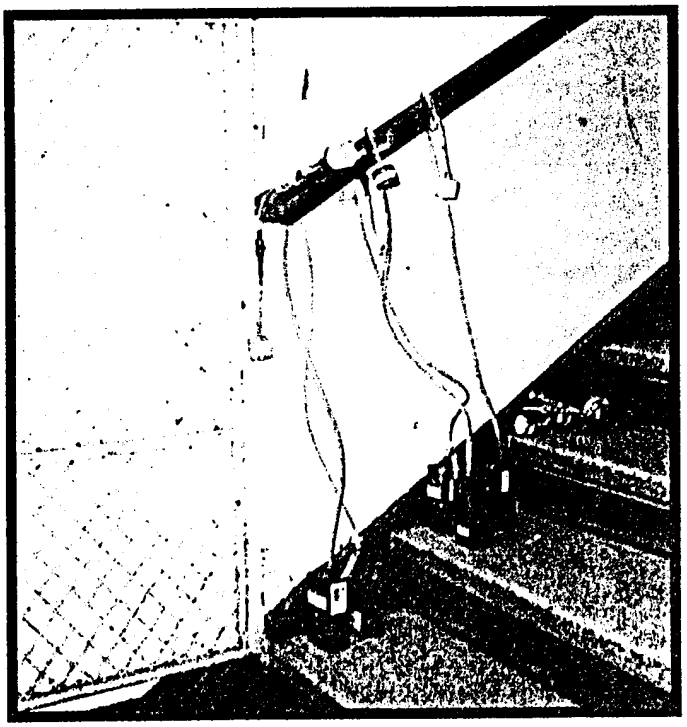
Photo 4: Air sampling location at the bottom of the second tier of stairs at 127 Fulton Street.
