**BUREAU OF ENVIRONMENTAL PROTECTION  
ASBESTOS AND LEAD CONTROL PROGRAM  
59-17 JUNCTION BOULEVARD  
CORONA, NY 11368**

**BULK  
ANALYSIS CHAIN OF CUSTODY**

Premise: 365 South End Ave Bldg # 400

# **ASBESTOS CONTROL PROGRAM EMERGENCY RESPONSE DIAGRAM**

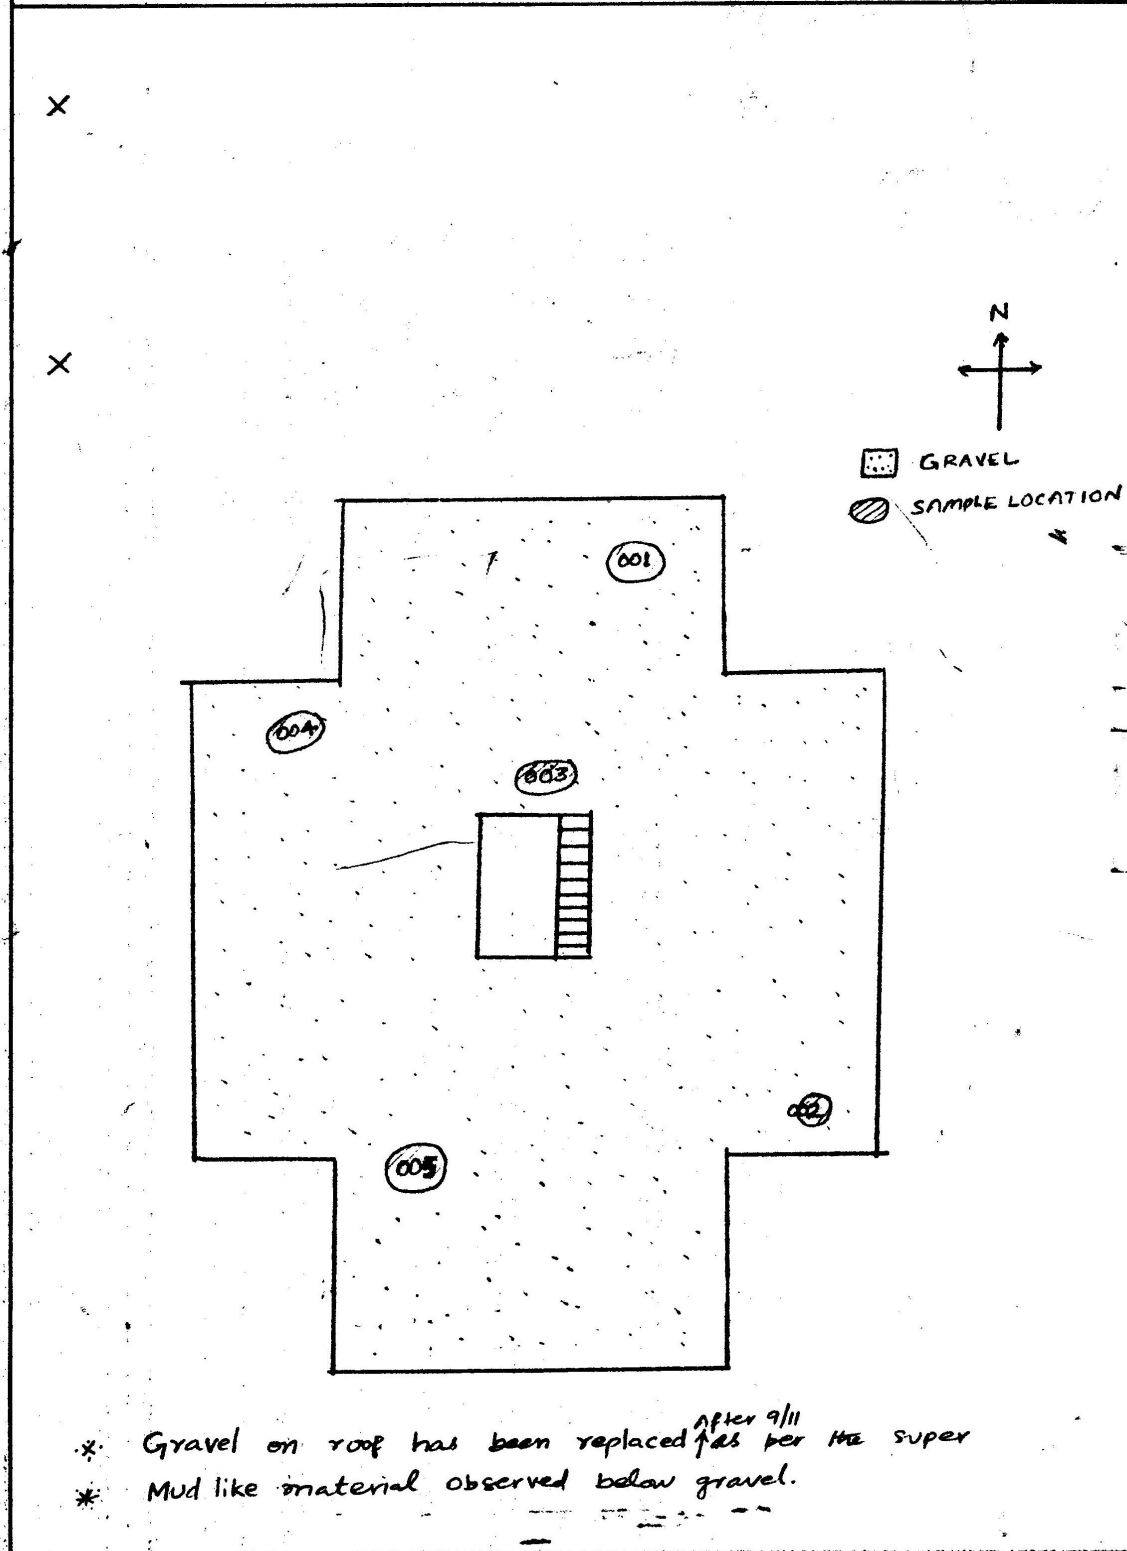
# ASBESTOS CONTROL PROGRAM EMERGENCY RESPONSE DIAGRAM

\* Gravel on roof has been replaced <sup>after 9/11</sup> as per the super  
\* Mud like material observed below gravel.
