**Re: Bulk Dust Sample Results for 130 Cedar Street, New York, NY.**

**JLC Environmental Consultants, Inc. (JLC)** was authorized to proceed with a survey to determine the presence of Asbestos Containing dust at the above-mentioned location.

JLC Project No. 04-3271

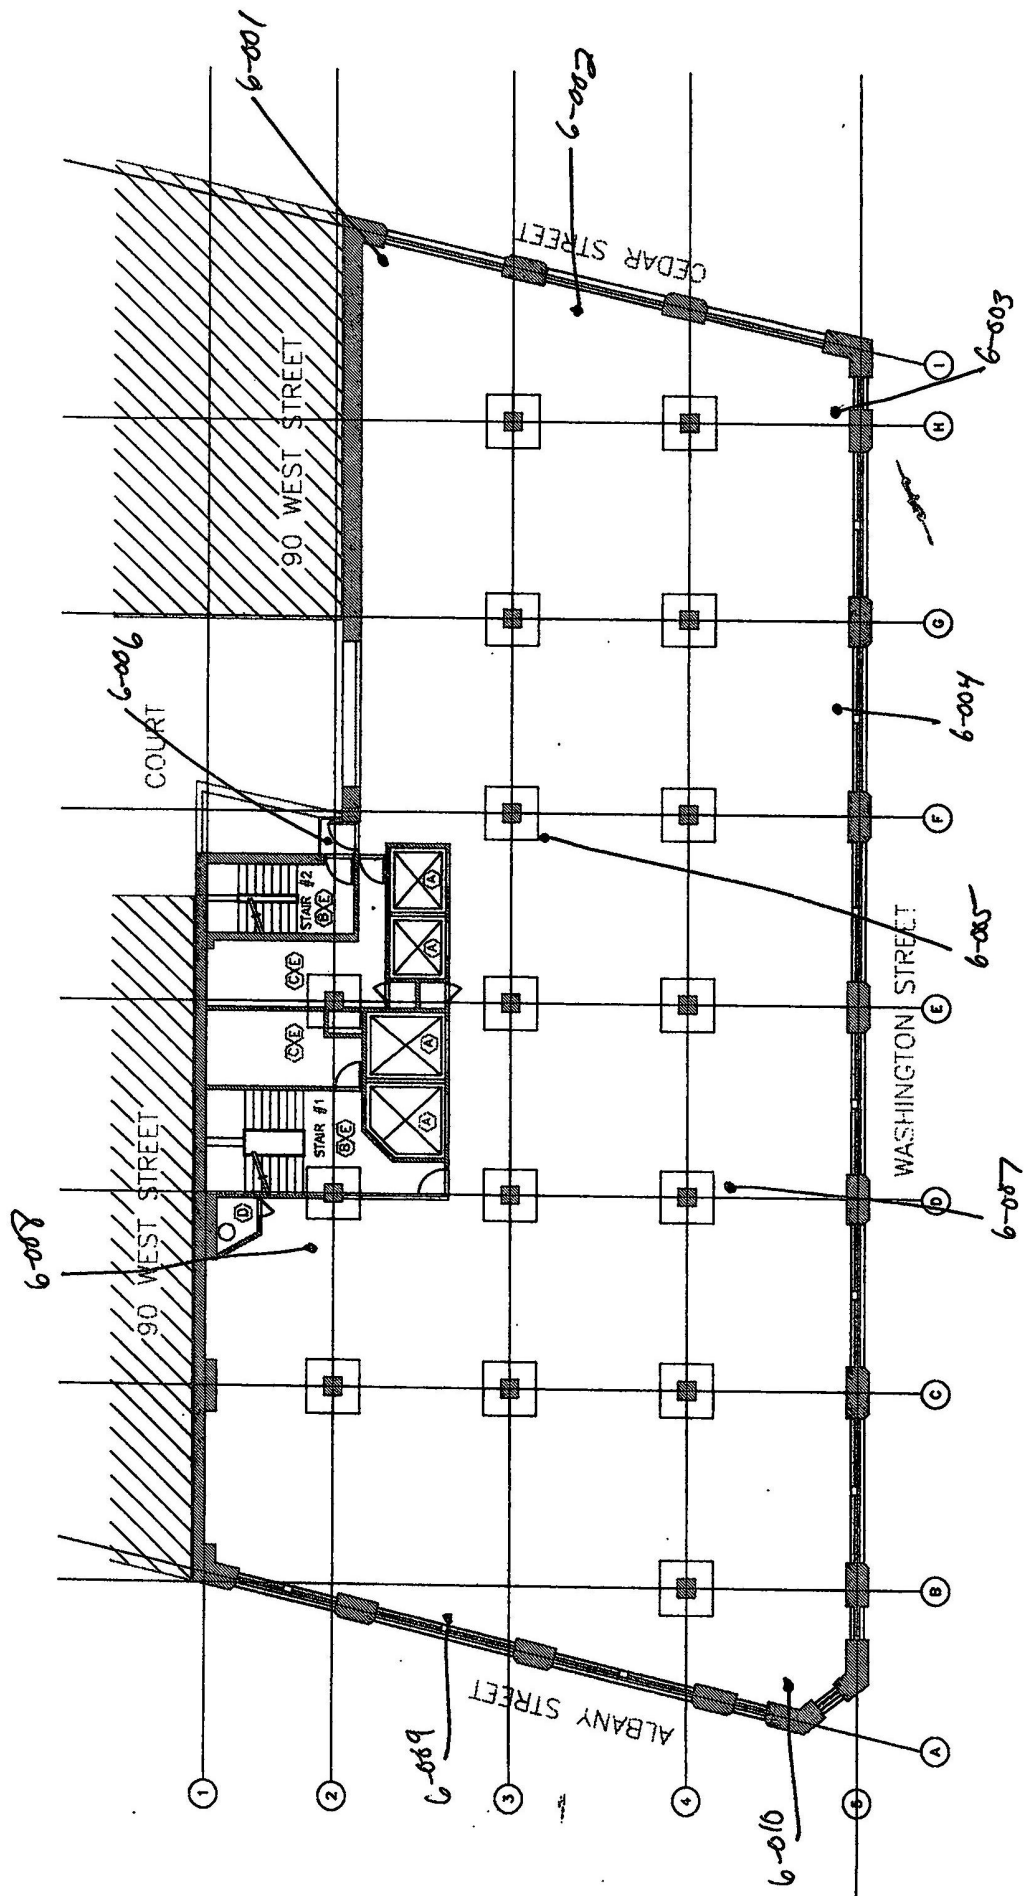
DATE 12/02/04  
INSPECTOR: PETER LUDWIG  
Approx 1,500 SF Skimcoat in  
poor condition See page 2  
of report (Samples 004-008)
