**DEPARTMENT OF ENVIRONMENTAL PROTECTION  
BUREAU OF SEWERS**

DSM #83-114D

REPORT FOR THE RECORD

RE: W.T.C. 776 Dey Street Escalator Underpass at  
Church Street, Borough of Manhattan

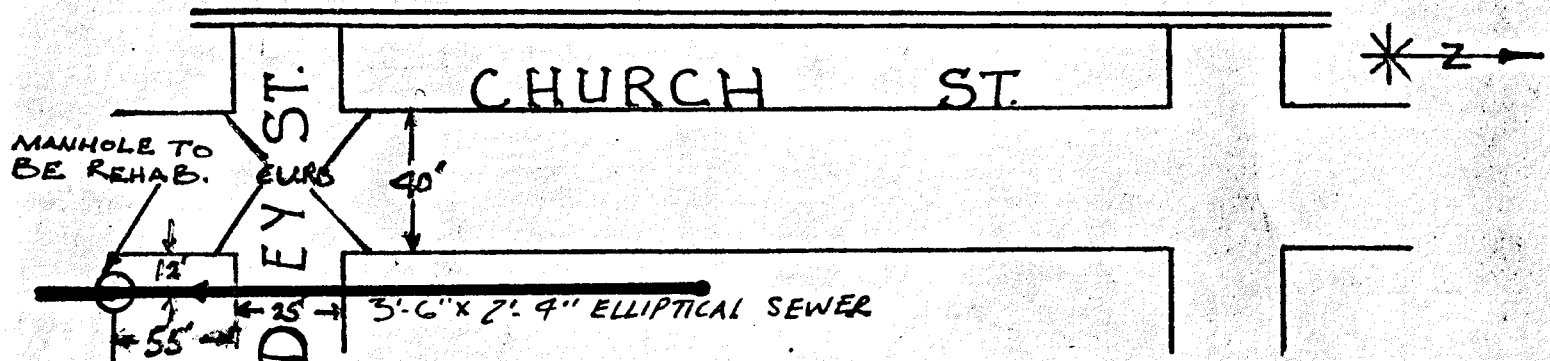
AND FOUND THE FOLLOWING CONDITION TO EXIST: MULTIPLE CRACKS

IN MANHOLE LOCATED SOUTH OF INTERSECTION ON E. SIDEWALK OF CHURCH STREET.
