Re: Independence Plaza North  
Results of Testing/Analysis of Carpet Mastic

## INSPECTION AND SAMPLE ANALYSIS REPORT

**Report Number:** 02227.

## **EXECUTIVE SUMMARY**

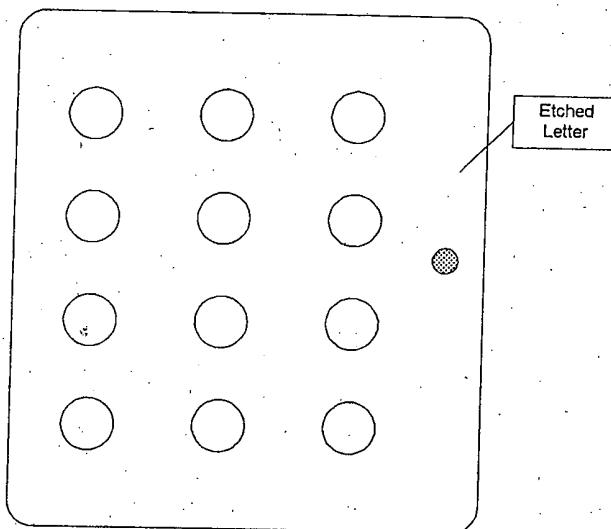
1. Place the samples into the order noted on the COC.
2. Set up a clean, pre-weighed crucible for each sample.
3. Set up a clean pre-weighed petri dish with a filter for each sample. Label each petri dish with with last 4 digits of the order number, the client sample number and the weight of the filter.
4. Separate floor tile from mastic if possible without cross contamination.
5. Always separate layers if possible unless client specifically instructs otherwise.
6. Remove 100-500mg. of sample and weigh in the pre-weighed crucible.
7. Place each crucible in the labeled 'muffin tin', using the crucible map to identify the sample numbers, as shown here:

Samples are placed in the tin beginning at the top left and proceeding across and down (as in reading a book).

Fill out the crucible map form with the identifying letter (etched on the tin) and the sample numbers in the order placed in the tin.
