## Preservation Briefs

## The Preservation of Historic Glazed Architectural Terra-Cotta

de Teel Patterson Tiller

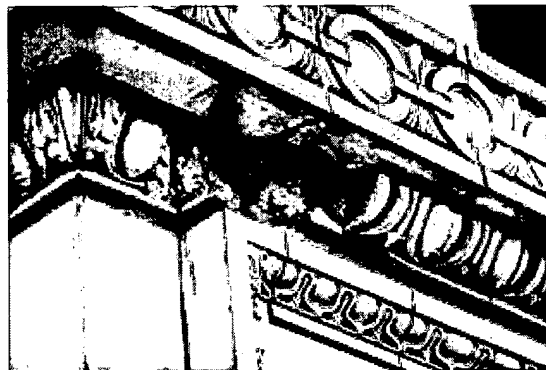
Material spalling is the result of excessive expansion of the porous tile body caused by water and freezing temperatures. This is a serious condition, often difficult to repair. Photo: NPS files.

Material spalling is a particularly severe situation. Not only is the visual integrity of the detailing impaired, but a large area of the porous underbody, webbing and metal anchoring is exposed to the destructive effects of further water
